# Cobblestone construction in the New World

## A restoration case study

**John Burnell**

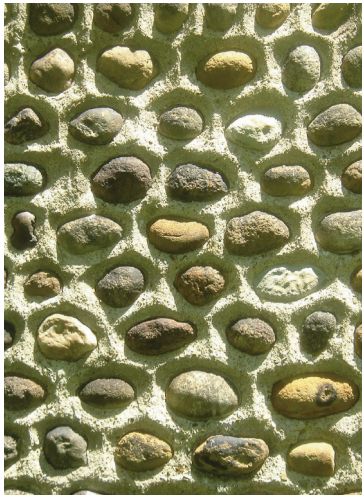
**Fig. 2** (above)  
Projecting mortar joints create a honeycomb effect.

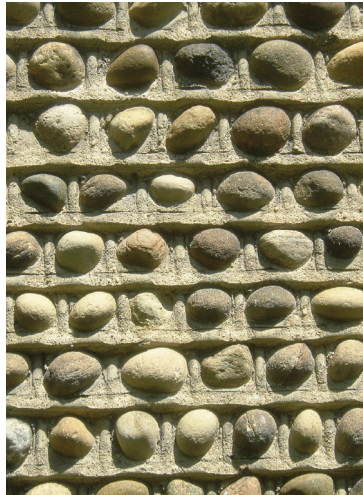
**Fig. 3** (above right)  
Refined cobble and jointing work on the front central block.

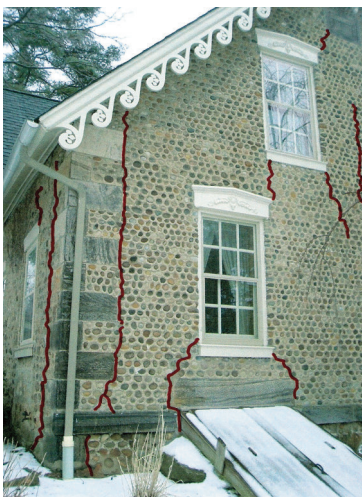
**Fig. 4** (below)  
Settlement cracks marked out in red.

Like many lime structures, the Howard House had been introduced to cement. While the house was, overall, in very good shape, over time narrow ( $\frac{1}{4}$  inch or less) shear vertical cracks had developed in the walls, some of which ran a good 15 to 20 feet from first storey to second [ground to first floor]. Settlement cracks had developed at all four corners of the wings, running vertically along the butt ends of the quoins from base to roofline. In the front, cracks radiated from all corners of the windows, from the lintels to the sills above and from the sills to the base below (Fig. 4). The widest crack (approximately 1.5 inch wide, see Fig. 5) ran from the stone lintel above the doorway to the sill of the window almost immediately above it. All cracks had been filled with several applications of cement-based mortars over the years and these were as unsightly as they were harmful to the masonry. Our job was to clean them up and get the right material back in.

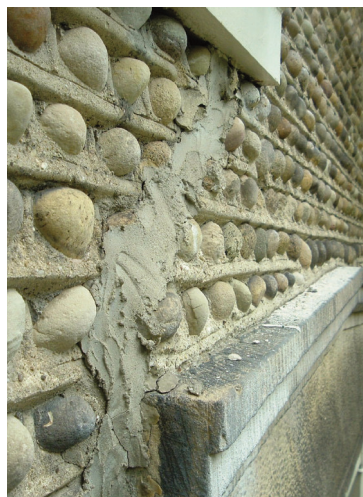
**Fig. 5** (below right)  
Crack running from doorway lintel to sill above.

In addition to the cracks in the mortar joints from all of the windows, the sandstone lintel over the front door was kicked out of plumb by about 1.5 inches, a state that appeared to be longstanding, judging from historic photographs. This wide joint was covered over with cement repair mortar, and its removal provided a glimpse at the interior of the wall and a good look at the lintel. We had not anticipated re-setting the lintel as part of our original proposal, thinking it would have to be completely removed to be re-set, but the removal of the mortar showed a relatively shallow (approximately 8-inch) lintel atop the wooden framework of the doorway. The lintel, it appeared, might be able to be pushed back into its original place, but not without some surgery; it would have to be separated from all surrounding masonry and the area behind the lintel would have to be cleaned out, and possibly cut back, in order to get it back in place.

All lintel work, fortunately, was able to be done without taking the lintel stone off the door-frame. The base of the lintel appeared to be cut somewhat shallow and slightly out of square, a sort of birth defect that gave it the inclination to slide forward over time. The space behind the lintel was cleaned out with a vacuum and the lintel levered back into place with a spud bar [crowbar]. We re-plumbed and re-set it in a shallow bed of mortar back upon the door framework.

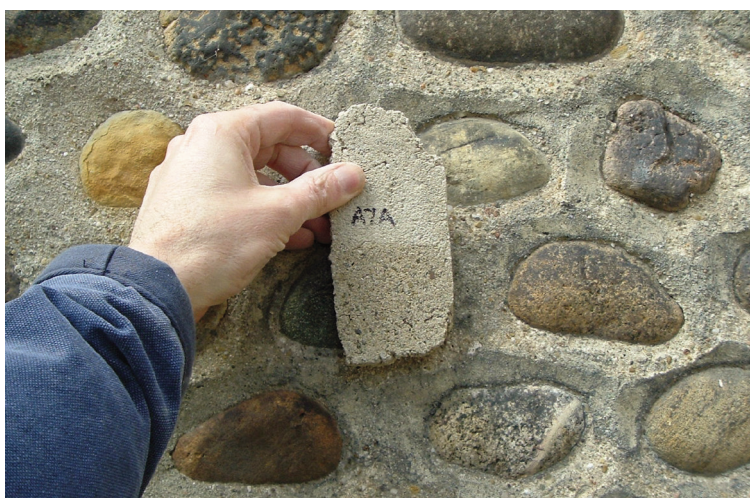
The creek that furnished the cobbles more than likely also furnished the sand. The coarse aggregate revealed in the mortar analysis closely resembled concrete sand and the surrounding area happens to have a wealth of sand and gravel pits, making a sand match fairly uncomplicated. Our next step was to create several samples to see if we could match the existing mortar. We formed six different mixes into patties, using a variety of sands with the following limes: a putty, a St Astier NHL 2, and a pre-tinted St Astier NHL 2. We let these cure in the lab and then wetted and brushed them with a restoration cleaner (Vana Trol from Prosoco, USA) to reveal the aggregate. The samples were taken on site and held against each wall in natural light to determine compatibility with the original mortar (Fig. 6).

**Fig. 6** (above)  
Examining a mortar sample.

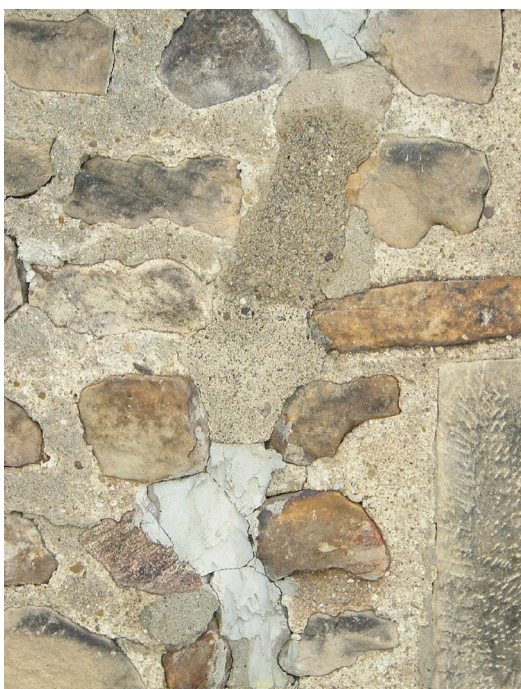
The mortar choices came down to three samples: a 1:2.5 putty/sand consisting of Niagara Putty, an aged dolomitic lime from Graymont Lime in north-west Ohio, and two NHL 2 mixes, a tinted and untinted 1:2.5 St Astier NHL 2/sand mix. The samples were put into two different sides of the house, allowed to cure, and then washed with acid and measured for matching in place. The putty and untinted NHL 2 both came very close to the original; the tinted NHL 2 matched well pre-acid wash, but came in darker afterwards (Fig. 7).

**Fig. 7** (left)  
Mortar mix with tinted NHL 2.

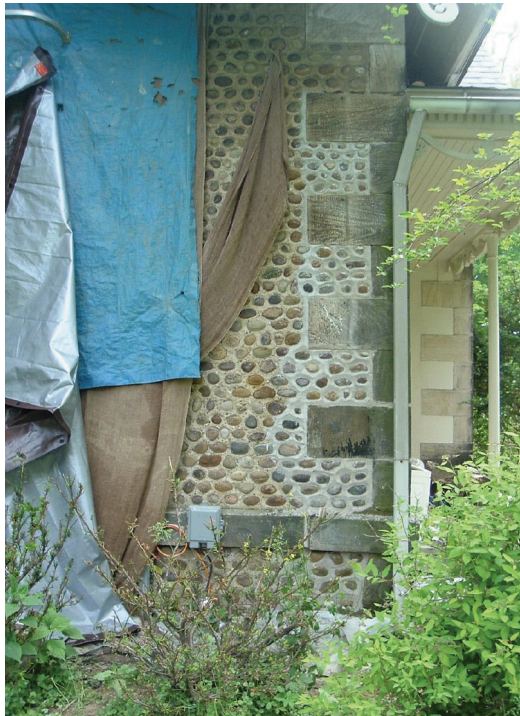
**Fig. 8** (right)  
The south-west corner, with NHL 3 mortar mix.

Around this time, the weather began to turn, as the work had commenced in early autumn. We switched to an NHL 3.5 to work on the south-west corner, which was where the weathering to the wall – and subsequent cement repair work – had been the most extensive (Fig. 8). The idea was to lessen the risk of frost failure by getting a little quicker initial set out of our mortar. To our dismay, the 3.5 cured to a greyish colour, even with the new sand and after it was brushed down with the Vana

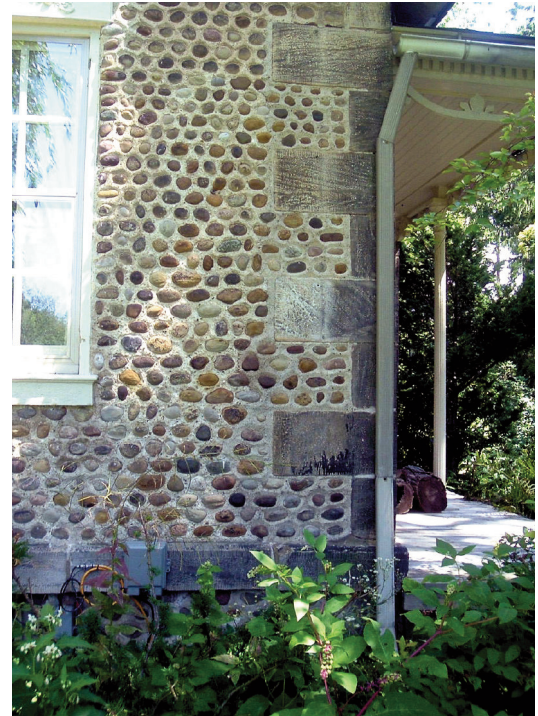
**Fig. 9** (far right)  
The south-west corner following application of a walnut-shell wash.

Trol. (Up to this point, we had worked exclusively with NHL 2; we were to learn the grey tone was characteristic of 3.5.) A few experiments with a wash made from crushed black walnut shells, a suggestion from our supplier, who had experience covering over cosmetic unpleasantnesses, did the trick and gave the repair mortar a closer blend to the original (Fig. 9).

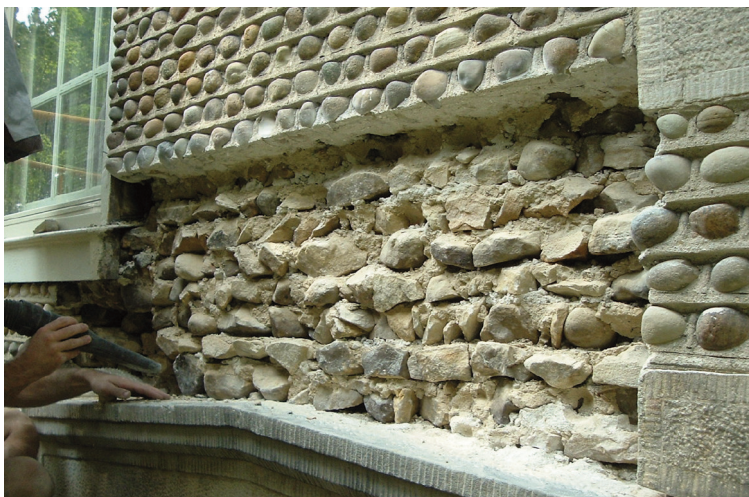
**Fig. 10** (below)  
Rubble coursing behind the outer skin of cobbles.

behind which was rubble coursing that had been levelled to each cobble course (Fig. 10). Especially noticeable was the brown colour of the mortar for the rubble coursing, which contrasted sharply with the cobble mortar (Fig. 11). Clay mortar formed the interior mortar, which was consistent with other interior mortars seen in vernacular work of the same era here. Some of the interior rubble, dislodged during the removal of the cobble coursing, was re-set with a similar mortar using NHL 2 with a clay/sand mix that a local gravel pit produces for baseball fields.

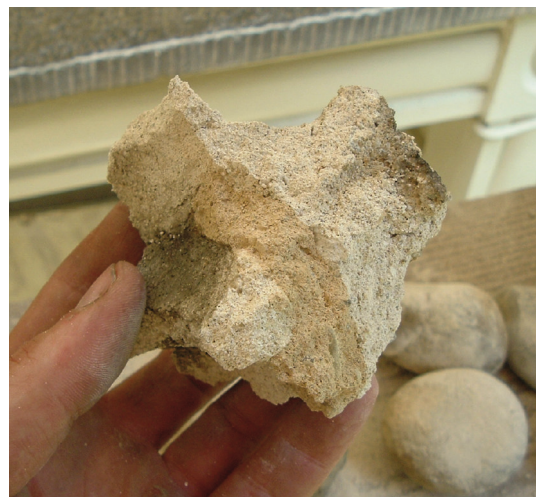
**Fig. 11** (below right)  
Differing mortars in the rubble and cobble skins.

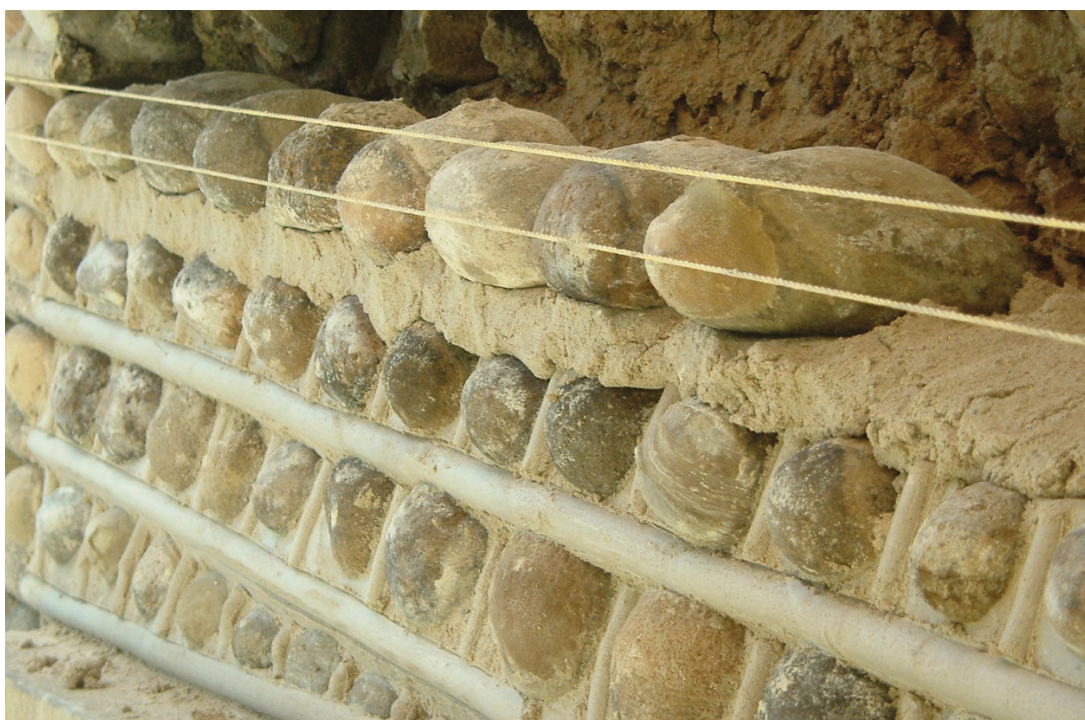
**Fig. 12** String lines were used in re-setting the cobble coursing.

Re-setting the cobble coursing, and making it match the original, was probably the biggest challenge of the project, and it came with its attendant hurdles. Smaller repairs on the front face allowed us to develop a technique for duplicating the jointing. Judging from the look of the original coursing, string lines were involved, and we were to make do with two (Fig. 12). At this stage we used a different mortar mix; we went strictly to a putty because of the delicate lines and ridges formed by the mortar. Also, the aggregate was

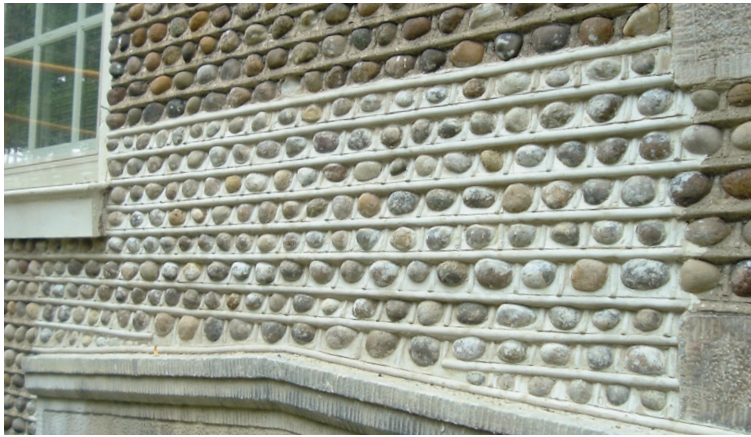
**Fig. 13** Initial repairs to the cobble coursing over the front-door lintel.

The onset of winter had led to a four-month pause in work on the house. Work had resumed in early summer and in direct sun. The cobblestone work above the lintel had been completed and left to cure (Fig. 13). A few weeks after completion the mortar, which had been kept shaded by a tarpaulin, was checked and found to be slower curing than the other mixes used on the house. A fingernail could still be easily dug in and my partner recognized the expression on my face of what he calls 'mortar anxiety'.

Two miscalculations had been made with the lintel mortar. The first was the putty. It was from a new bucket, but that was all that was new about it; it was some home-brew putty I'd made from a bag of hydrated lime back a few years when I was first getting the lime bug. Though it had congealed into a putty, it was, in fact, a dead lime from a bag that had probably already been largely carbonated. In a mix-up, it made its way to the job site. Compounding the weakness of the lintel mortar was the sand, which probably had a bit too much of its larger aggregate screened out of it. The mortar had to be removed.

Fortunately, the work re-doing the lintel went expeditiously; the jointing techniques had been practised and we had a clearer idea of our mortar mix. Not ones to take any more chances, we ordered a new bucket of putty from Graymont Lime and switched to a more fully graded aggregate. Sure enough, the mortar was crisp and resistant to the fingernail after several weeks of curing. A slight amount of buff pigment had been added to the mix to darken it slightly, as the mortar in the front had a deeper tone than that found on other sides. A wash with heavily diluted acid and a toothbrush was used to remove laitance and reveal the aggregate, bringing the mortar colour closer in line with the original (Fig. 14). (The acid was then washed off with water.)

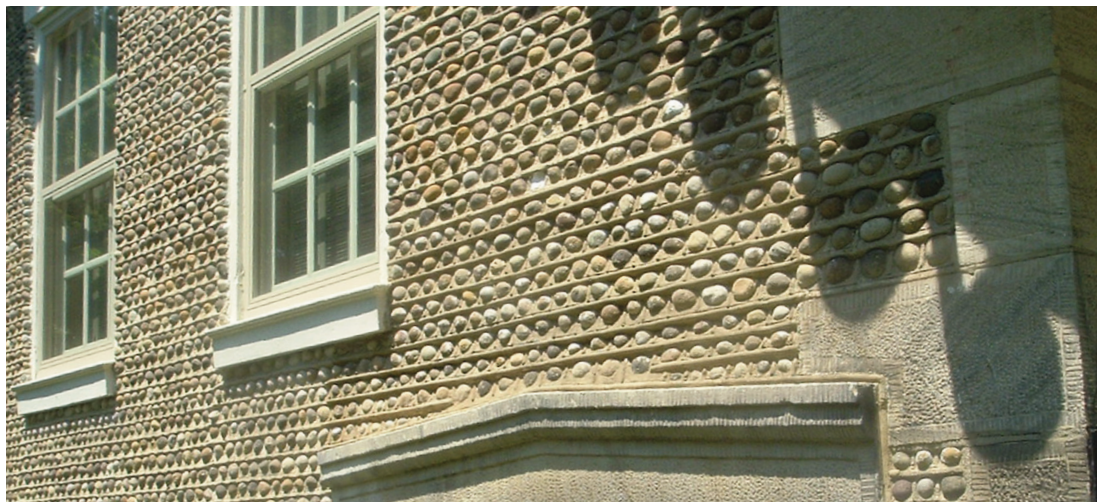
**Fig. 14** Cobblestone work above the front door, following final repairs.
