## GEOLOGY AND THE DEVELOPMENT OF UPSTATE NEW YORK'S DISTINCTIVE COBBLESTONE ARCHITECTURE

D. BROOKS MCKINNEY  
Department of Geoscience  
Hobart and William Smith Colleges  
Geneva, NY 14532  
Email: dbmck@hws.edu

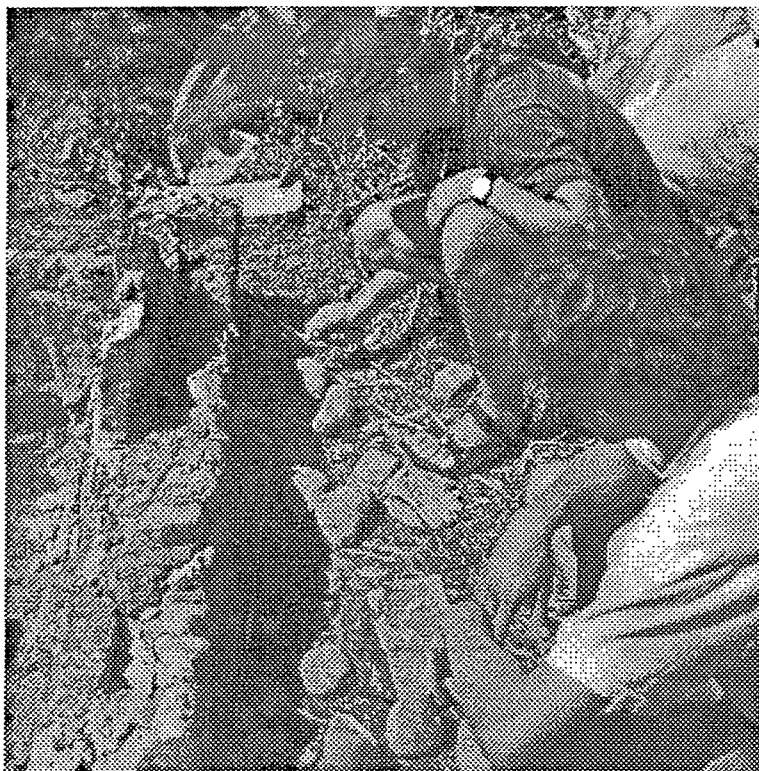
Figure 3. A small cobblestone wall under construction. Note the “backing stones” that form the back of the wall and the line of cobbles along the front. In between is the “trough” which will later be filled with rubble and mortar in advance of starting the next course.

Figure 3 shows a small cobblestone wall under construction. Working from a foundation of large blocks, a set of backing stones for the inside wall is laid up and the quoins are laid true and square. To “fill” the space between the quoins with cobblestones, a thick bed of mortar is laid down. Individual size-sorted cobbles are then placed on this mortar bed so that their upper surfaces define a roughly horizontal line and the ends that project outward from the wall are flush with a guide string strung between the corners of the two quoins. These cobbles are placed so that they have approximately 2 to 4 cm gap between them. Once the stones are thus arranged, the mason fills the gaps between stones with mortar. As the mortar is thixotropic, this is best done by flinging a wad of mortar into the gap with a small trowel; repeated flings fill the gap up to the height of the stones on either side. With the gaps between cobbles filled, the joints are formed using a flat pointing trowel. The vertical joints across the entire wall are formed first. Using upward strokes, first on one and then the other side of the joint’s center line, the mason creates vertical to inward sloping surfaces that meet as a broad V. Typically this is broader at the base than the top. Once all the vertical joints for a course have been formed, the mason shapes the upper surfaces of the two angled surfaces that will form the horizontal joint at the base of the course. This upper surface is created by running the trowel horizontally along the base of the stones, pressing inward and downward to create a mortar “shelf” that is angled down and away from the wall at roughly a 45° angle. Finally, the mason uses a slicing motion to cut away the excess mortar along this shelf and in the

process forms the face of the lower part of the horizontal joint, a surface that slopes inward and down. The visual “line” of the joint is formed by the intersection of the two surfaces; while contact of the upper and lower surfaces of the joint with the cobbles may be very irregular, the line of the joint is produced by the intersection of the joint’s upper and lower surfaces and its linearity and horizontality is limited only by the mason’s skill.

Completion of the joint work for a course leaves an irregular trough between the backing stones and the stones laid up as the horizontal cobblestone course. This trough is important because it compensates for the different sizes of the cobblestones—larger stones can extend farther back into the trough than shorter ones. Such larger stones help to strengthen the final wall by “tying” the cobblestone work to the wall’s interior. After one or two courses of cobblestone is laid, this trough is filled with mortar and waste stones, rocks that are not well sized shaped, or colored for the cobblestone exterior. Thus, cobblestone walls are a type of rubble-filled mortar construction.
