A SURVEY OF COBBLESTONE MASONRY
IN THE RUSH - MINDON AREA

submitted by R. B. Wood

May 18, 1955

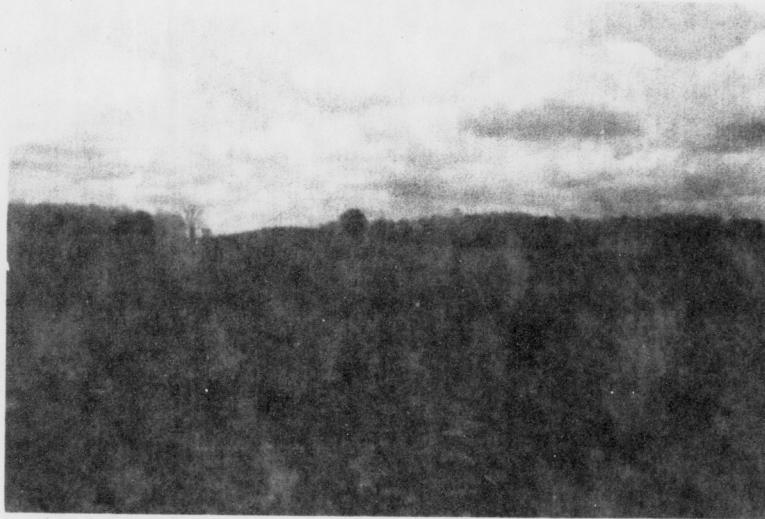
#1.

In this area, all of the cobblestones used came directly from the fields around the farmers' homes. Photo #1 illustrates a field nearly covered with the small cobbles even after years of cleaning up by farmers wishing to rid the land of the annoying rocks. The majority of cobbles used were either of the red Medina sandstone variety of of various grey, brown, or yellowish-tan stones. The story of many of the older natives has it that while the husband was doing the farmwork, ~~the~~ women and children would pull a sled ^{or cart} covered by a ~~board~~ board containing three or four holes of the desired size. When stones were picked up that would fit through the board, excluding pebbles of course, they were brought back to be sorted and used in the construction of the new building.

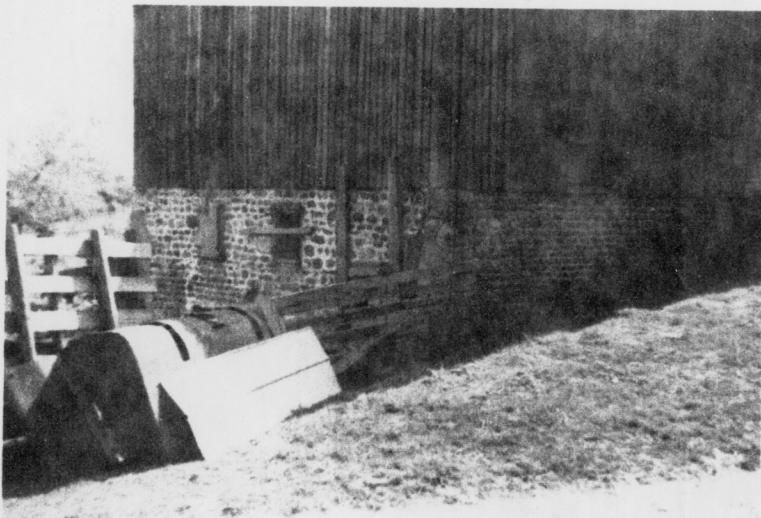
#2

The most common barn foundation in the area is the one shown on the left side of photo #2. Here the stones of varying sizes were laid in a somewhat horizontal effect with a flush cement joint. The right wall of this barn is illustrative of the later type of facing put on cobblestone masonry. The barn was probably built during a later period, but the sides and rear were done in the rougher fashion because of the simplicity of stone selection and construction.

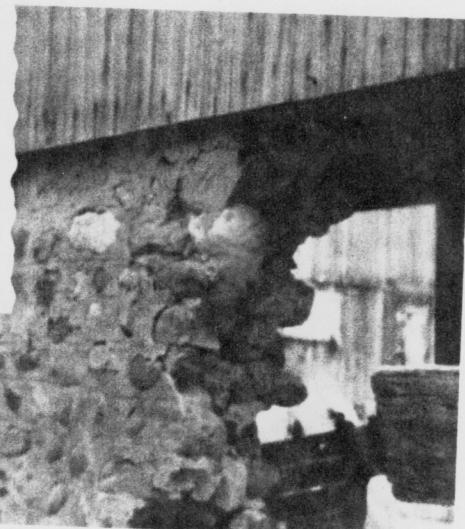
Photograph #3 shows what I would call the next development of the cobblestone wall. The wall construction is similar, with the ^{bounder} two layers of stone cemented together and often locked with longer stones., and with many of the small surfaces showing through the outer layer being merely a small end of larger stones. The difference here lies in the mason's attempt at heightening the horizontality by running the point of his trowel between the layers of stone and forming a crudely straight joint.

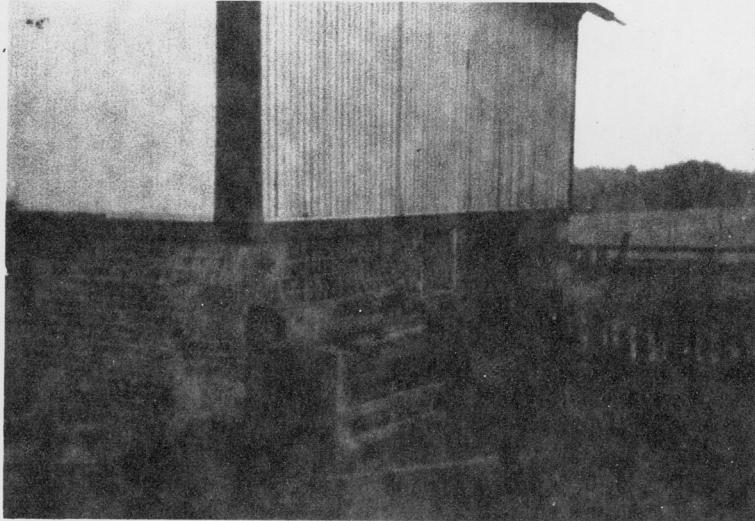
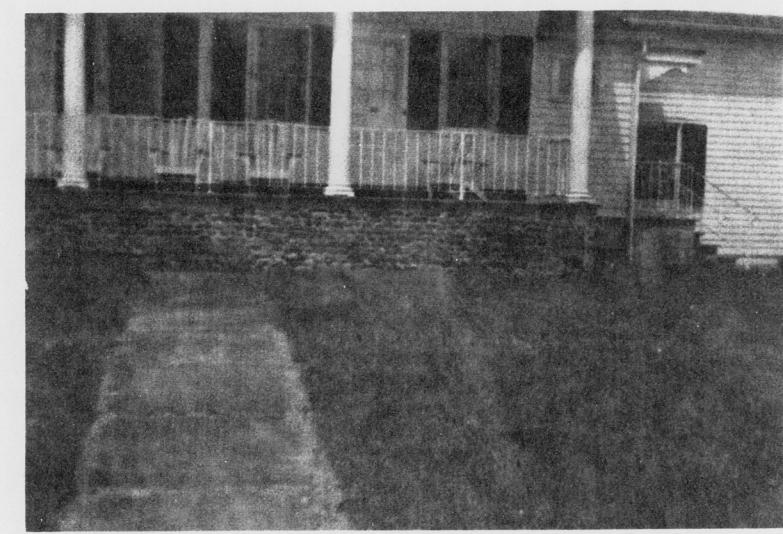
#10.

Photograph #10 shows a ~~home~~ very close to that of Jones', built at approximately the same time and possibly worked on by the same mason.

This again illustrates the use of the cobblestone facing for beautification ^{of} ~~for~~ high foundation walls.

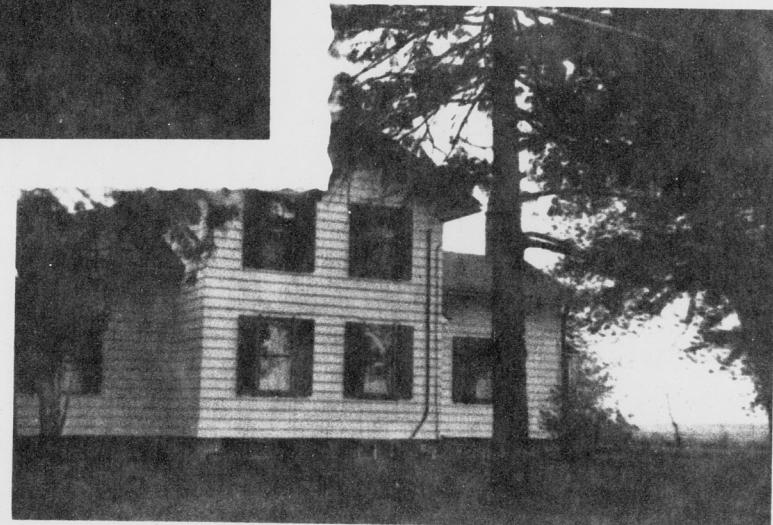
#9.

Photographs #8 and #9 of the Eliza Jones home on West Henrietta Road, built in 1863, illustrate the use of cobblestone facing on the foundations of many homes. In #8 ~~the foundation under~~ the two wings were added about fifty years later, and the foundations were built by

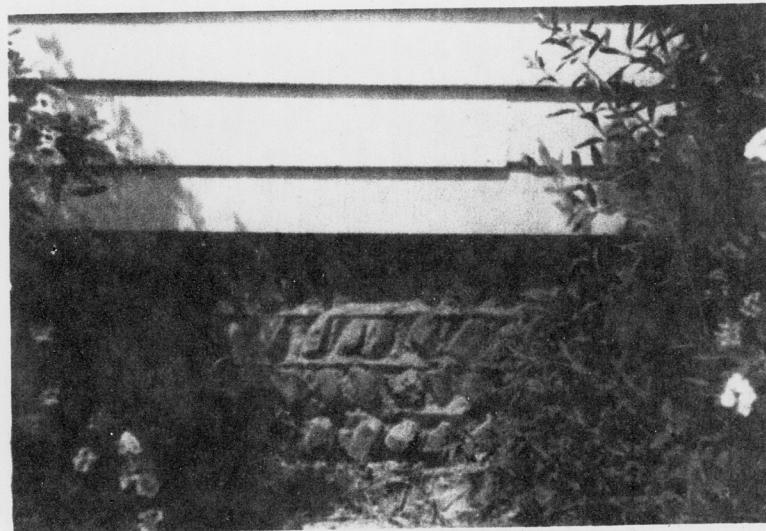
The only illustration I was able to find in the area of the herringbone effect in the laying of the cobbles, was in the foundation of a home on the Boughton Hill Road, Photo #11. Small, rectangular, sharp-edged stones were laid in this zig-zag pattern with a strong V horizontal joint done with the mason's trowel. The sides and rear of this home have the common horizontal, four-rows-to-a-quoin construction and the stones are more of the round-edged variety.

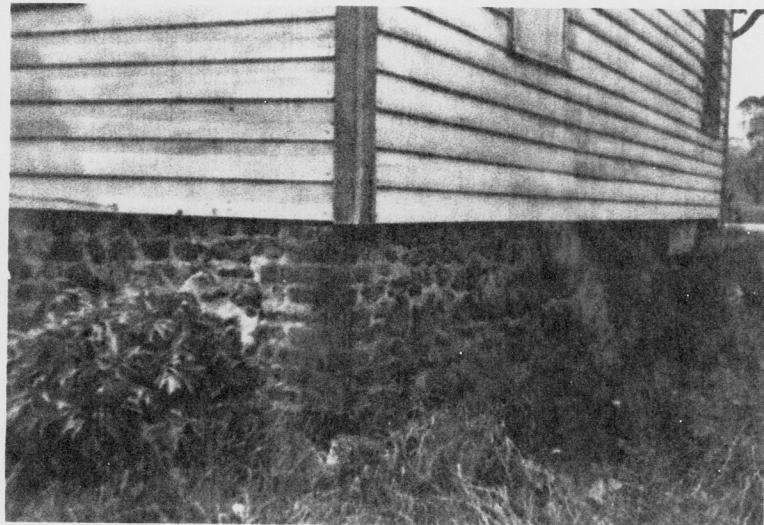
A very peculiar feature, illustrated twice later, once in a smokehouse and then again in a home, was found in the foundation of a house on Mile Square Road, shown in Photo #12. Here, instead of large, squared stones used for corner quoines, the mason used brick. The laying of the cobbles was very crude, with a horizontal effect, but no attempt at beautification of the cement joint or uniformity of stone size. Neither is there any uniformity in the laying of the brick quoines. Either one or two bricks were used as needed to complete the row and strengthen and square the corner.

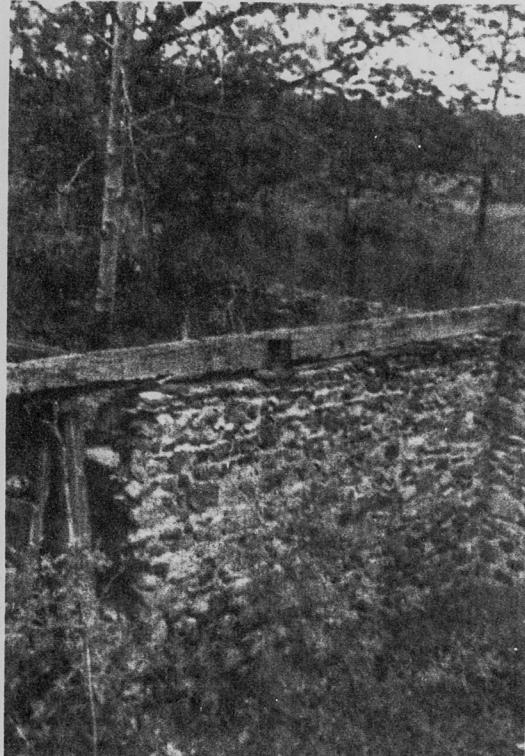
From the ruins in Photos #13 and #14 can be seen the typical construction of an entire foundation. Larger stones were laid with little horizontal effect and no regard for pleasant detail from the bottom of the basement up to the ground level. From here to the sill, upon which was constructed a wooden frame building, the wall is faced with finer cobbles laid in a more pleasing horizontal manner.

Here the quoines were of roughly-hewed, twelve-inch-high limestone, and to a quoine were laid four or five rows of cobbles.

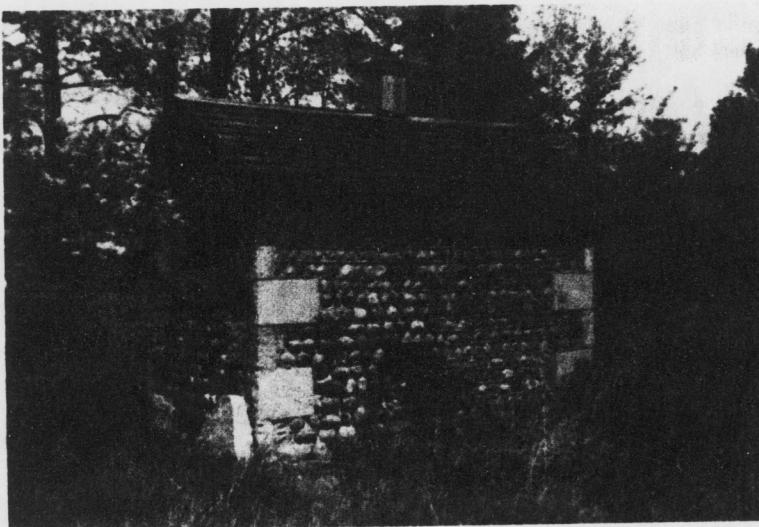
#15.

On the same site there stands a cobblestone smokehouse, Photo #15, very similar in layout to five others found in the area. This structure on Clover Road has nine inch, roughly-squared corner quoines, with rows of many-colored cobbles, four per quoine in front and three on the sides and rear. The view shows the side and rear of the smokehouse with patches of later ~~late~~ masonry, probably added where brick fire walls had been replaced.

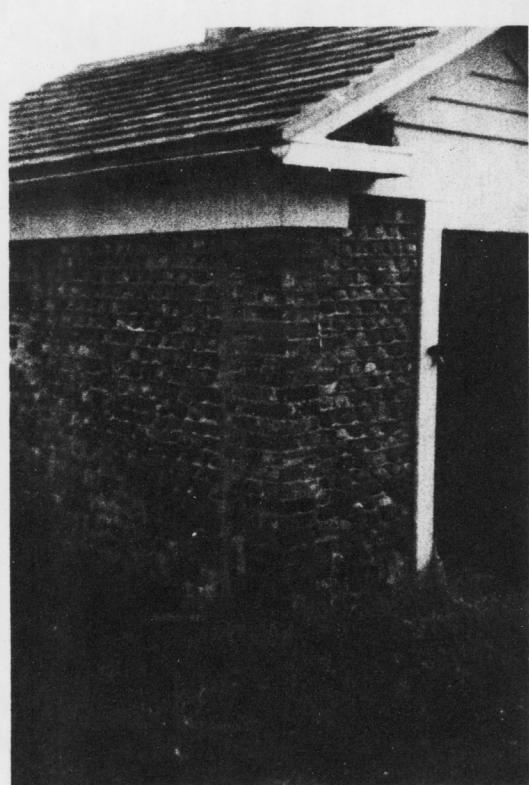
#16.

Speaking of fire walls, some of the smokehouses had a rear and often part of the sides of brick because of its greater resistance to the heat of the fire used to smoke the home-cured meat. However, all

of the brick fire walls have collapsed, ~~or~~ have been replaced because of the lack of conformity. In the smokehouse, illustrated in Photo #16, bricks, presumably left over from the building of the fire walls, were used to strengthen the corners of the structure. Built on the same farm as the barn illustrated in Photo #4, and believed at the same time, perhaps uniformity in the smokehouse was a reason for the brick quoins. The mason, whether the same or not, used roughly squared, stone quoins in the barn, however.

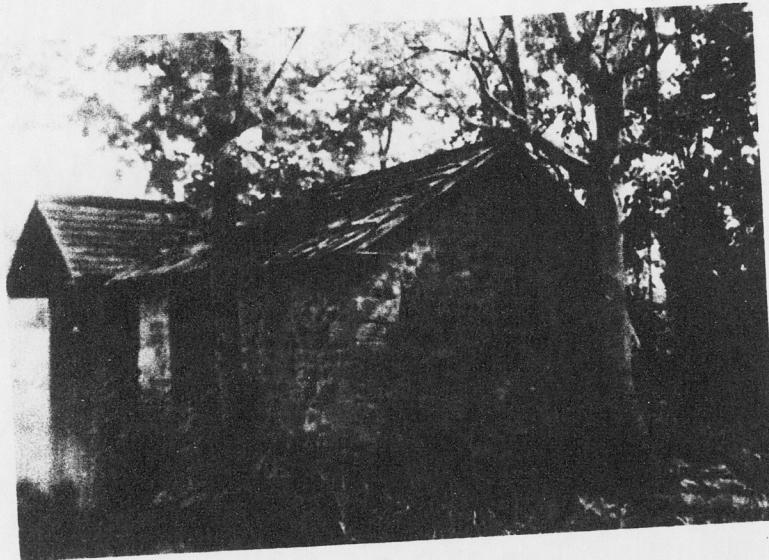
#17.

Photograph #17 shows what seems to be a very early-constructed smokehouse on the Mendon Road. The mason used varied sizes and colors of cobblestones with little horizontal effect. Also, the corner quoins were smaller, roughly cut stones of varying sizes. Photos #18 through #20 illustrate other smokehouses of common cobblestone construction. #18 is the only other one which originally had a brick fire-wall. #20 shows not only an entranceway, but also a small door in the section where the fire was built. More than likely, the fire was built on some sort of platform, and the fuel was inserted through this opening.

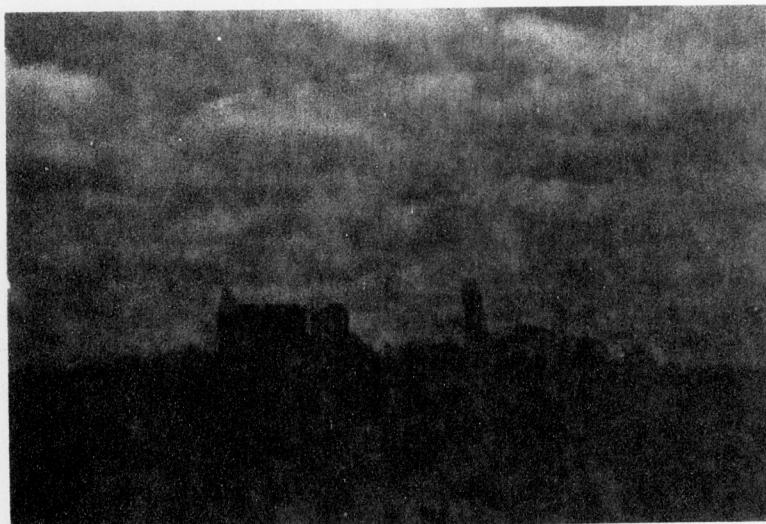
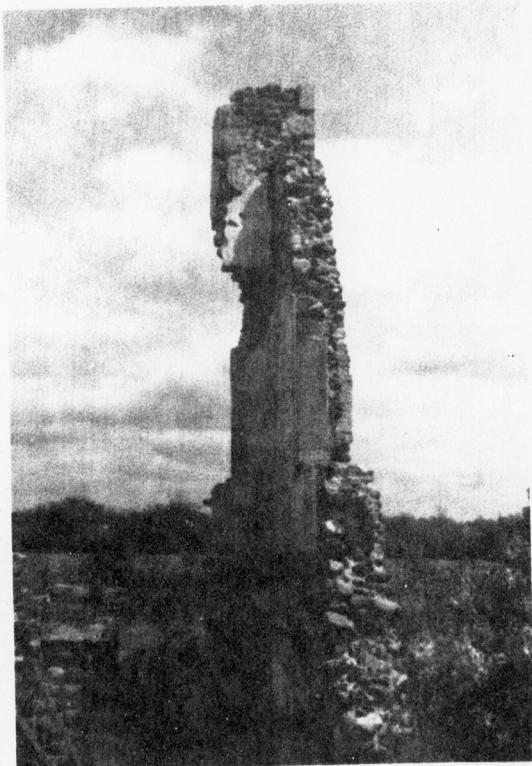
~~In~~ Subject #21, found on Sheldon Road, Mendon, is a very enlightening ruins of what ~~must~~ have been quite a large, beautiful home. #21-1 shows the remains as they appear from the road, and from it can be seen that the tall, remaining wall on the right is part of a two-story section; whereas, on the left can be seen a story-and-a-half appendage, but there is no indication whatever that this was a later addition. #21-2 shows the two story wall and illustrates certain common cobblestone masonry techniques as inside and outside layers of stones, a narrowing out of the wall from bottom of about twenty inches to top of about sixteen, plaster applied directly to the inner side of the masonry wall, and the basement foundation done of larger, rougher stones. #21-3 shows not only a cutaway of the wall, and the use of smaller, squared, grey limestone as decoration around the windows, but also the detail of the masonry. Many of the cobbles are of the red/

Medina sandstone variety and the rest of many different varieties, laid in good horizontal rows with crude V-shaped horizontal joints in the tan-colored, crumbly cement. There was no attempt made at an effective vertical joint. No quoines remain on the front corners, but from the size of the spaces, the construction was probably four rows to the quoine. #21-4 shows the lower-story, northern appendage with its unfaced inner surface and abrupt corner on the northern wall. This stone ending is evidence of perhaps an open side to a woodshed or a back room.

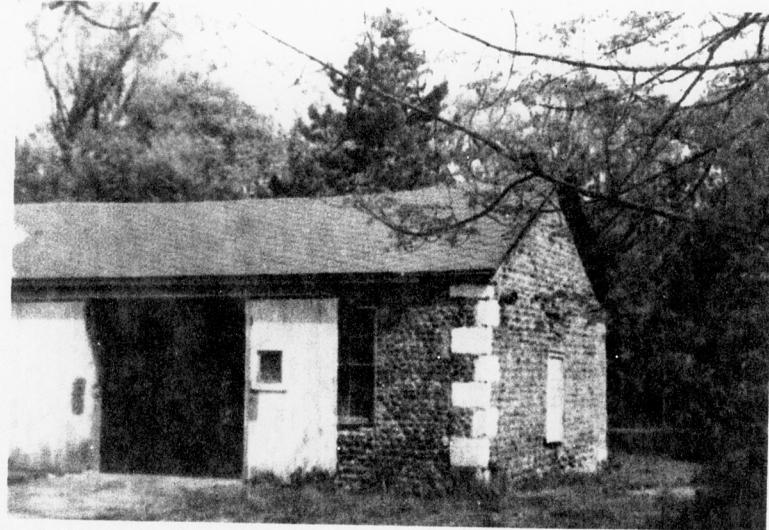
#23.

Found on the Mendon Road is this section of a former single story, two-room house, now made into a garage (Subject #23). On the front and side the wall contains many red sandstone cobbles, laid four rows to the roughly-squared quoine with a very crude attempt at a V horizontal joint. The rear wall is constructed of much larger stones, laid in horizontal rows, but with an almost flush surface and no outstanding joint effect.

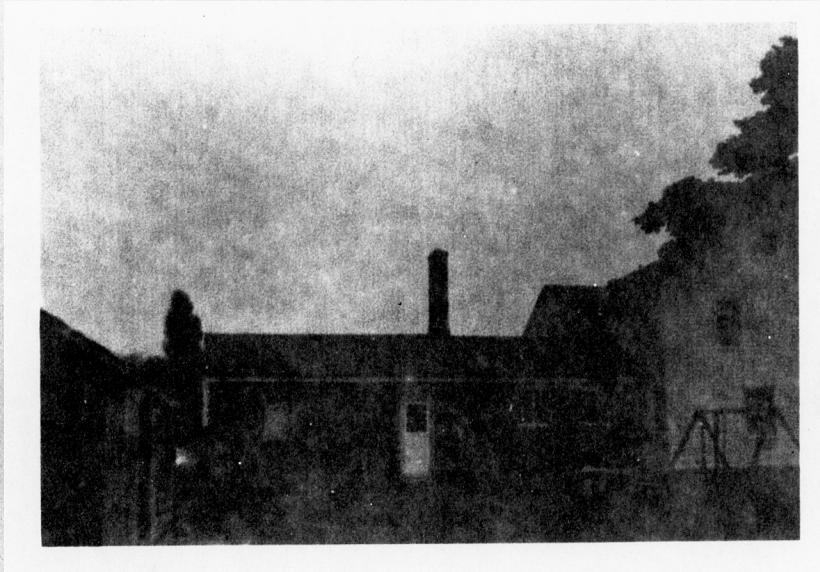
#24.

Subject #24 is a single cobblestone wall, believed built in 1835. There is no evidence that a complete cobblestone structure was built at the time, but the construction of the wall, with the door and window openings spaced with such little regard for symmetry, must have been in the rear of the building. Thus, it is probable that it was not the only wall of cobblestone. The stones are of various types and colors laid four rows to the quoine with a uniform but narrow horizontal V joint.

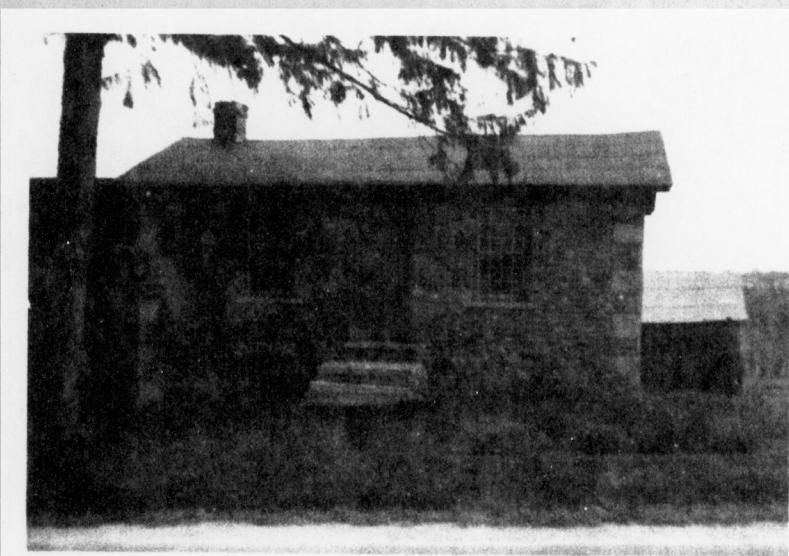
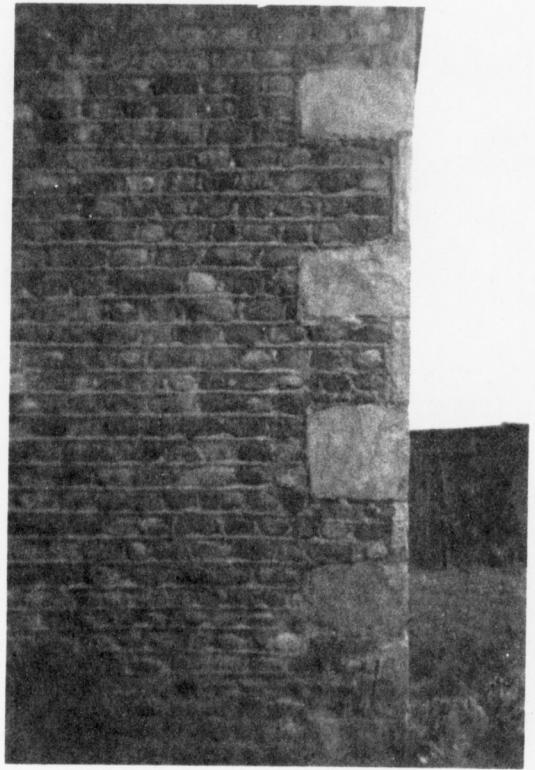
Subject #25, in West Rush is a single-story, two room house of red and tan cobbles. The cement used is very rough and full of pebbles, formed into a V at the horizontal joints with an attempt at a V shaped vertical joint, never breaking the horizontal line. The cobbles are laid three to three-and-a-half rows to the quoine which sometimes vary from nine to nine-and-a-half inches in height. The arches over the doorway and windows are of long, flat, rounded stones standing on end. Very conspicuous are the small-paned windows of old crude glass.

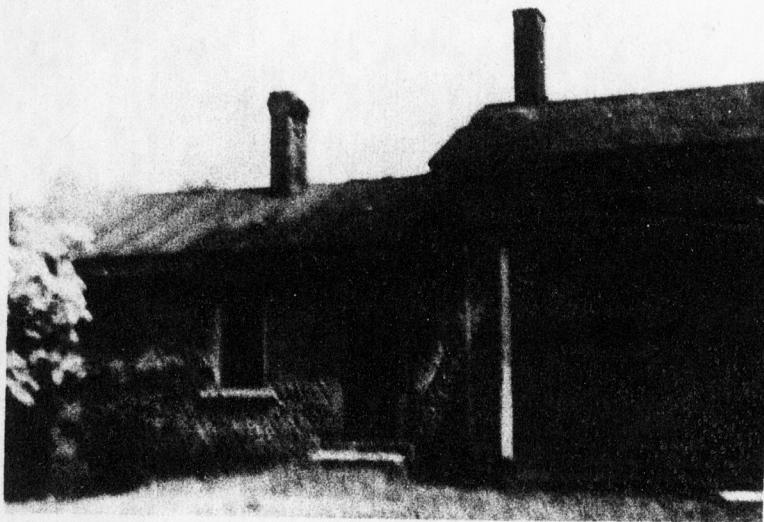
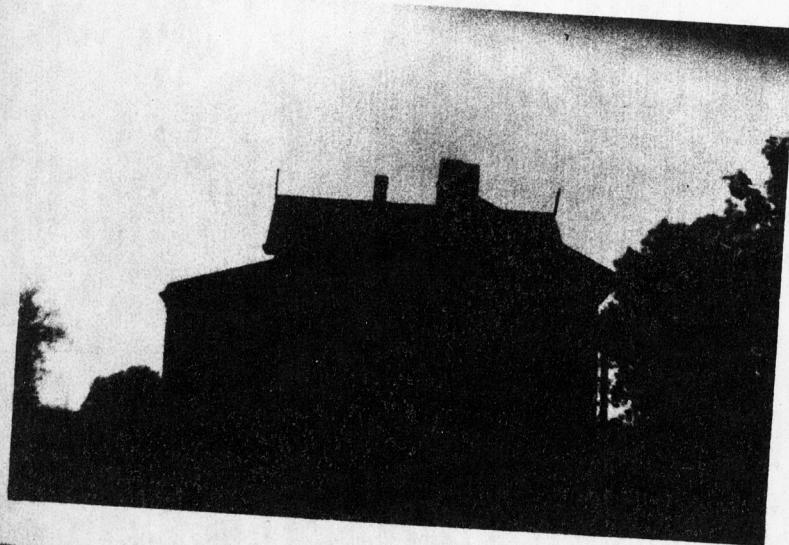
On the Rush-Honeoye Falls Road, Subject #26 is a one-story, one-room-in-width house, with a lean-to appendage on the rear, shown in #26-3. The cobbles in the front wall, are more nearly round, and many are of red sandstone. They are laid three rows to a roughly squared, eight-inch, grey, limestone quoine. In view #26-4 can be seen

the rear wall of the lean-to, very roughly constructed of various sized and shaped stones and partially covered with cement. #26-3 also shows a frilly, carved ornament hanging from the roof.

In #26-3 (arrow) can be seen patched portions where there were four-inch-square openings. On the rear wall there were four such holes and on the side two. The farmer's explanation was that they were portholes for Indian fighting, but, then, he also said that the house was constructed in 1776; I'm afraid he is slightly inclined toward over-imagination.

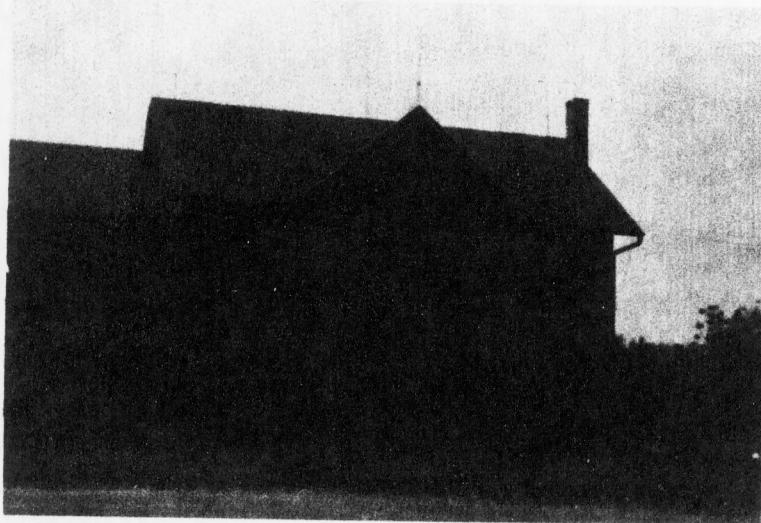
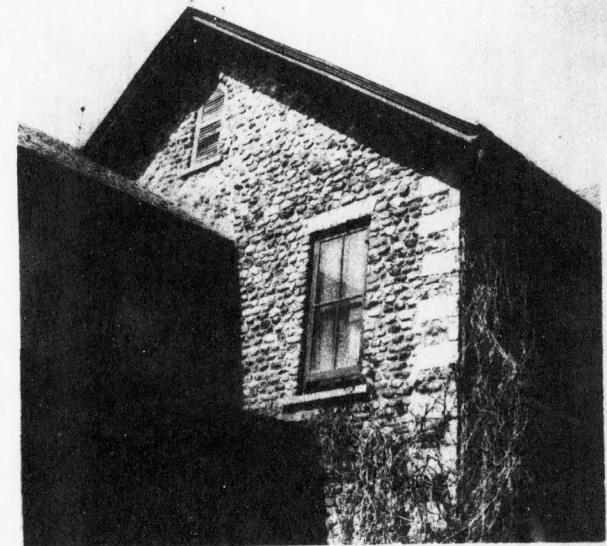
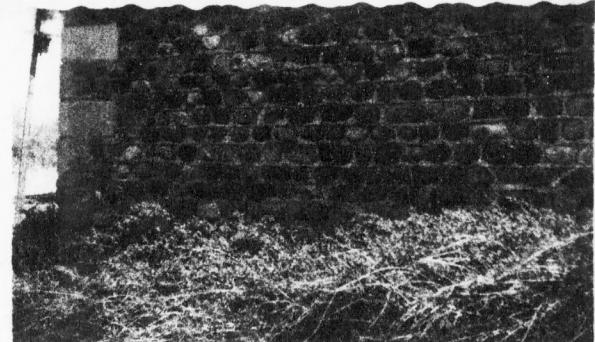
Subject #27 is a Victorian-style two-story home of red and tan cobbles. The stones were laid three rows to nine-inch quincine in front and, on the sides, ~~are quite unique~~ and rear, from two to two-and-a-half rows.

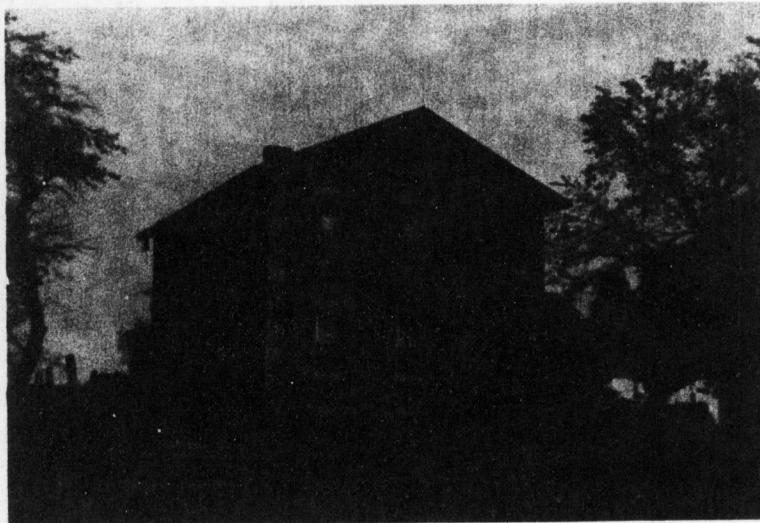
#28-1

Subject #28, on Lyons Road, Rush, is a Post-Colonial home built of many colorful, various types of cobbles laid three-and-a-half to four-and-a-half rows per quoine all the way around the house. The arches over the plain doorway and the windows are of very smoothly-squared, grey limestone, the same as the corner quoines. Peculiarly, the narrow side faces the road and contains the main entrance. This house is believed to have been built at the same time as subjects #29 and #30, by the same English masons in the customary manner of working for a few days on one structure then moving to the next to allow the formerly laid section to harden and settle. It is a legend that the masons' wages were one dollar a day, board, and a gallon of home-distilled whiskey.

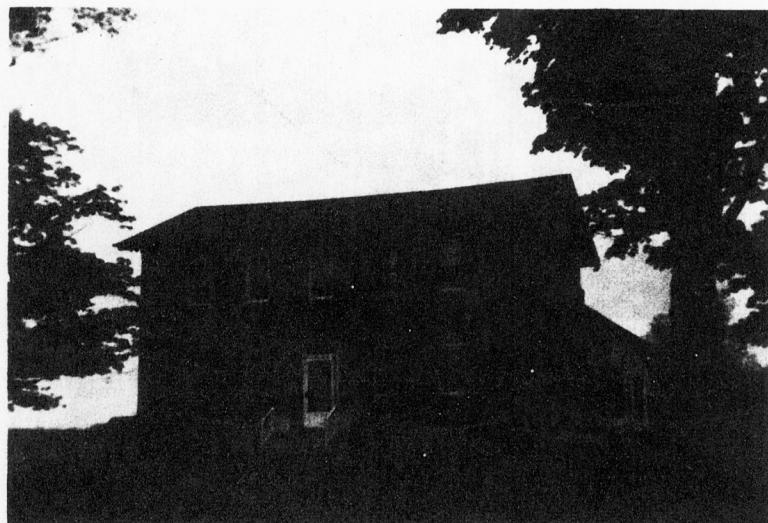
This Steffen Home on Clover Road (Subject #29) is a two-story structure, Post-Colonial, with a five-bay facade and a typical colonial floor plan of bisecting hallway, two-room depth. The arches are of long, flat stones laid on end. The cobbles are all of similar size and ~~shape~~, of many different colors, laid three or four rows to the quoins of about ten inches. In the front view, one can see different coloration around the doorway, and a protruding beam--there must have been a larger ~~porchway~~ when the house was first built.

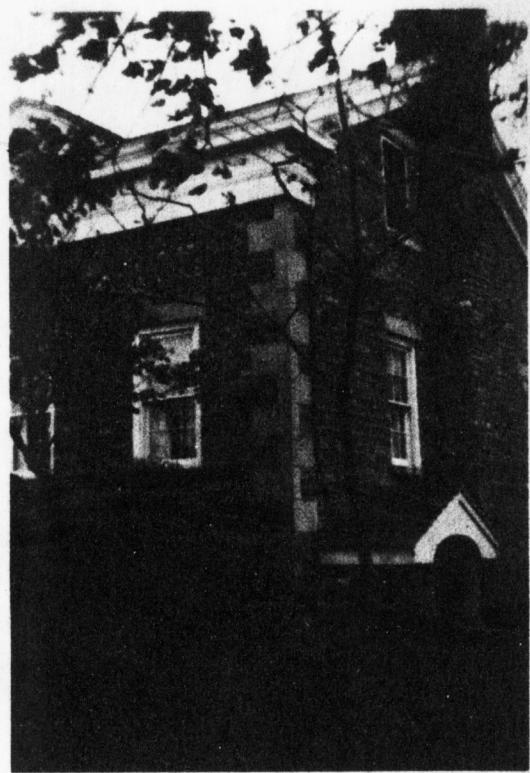
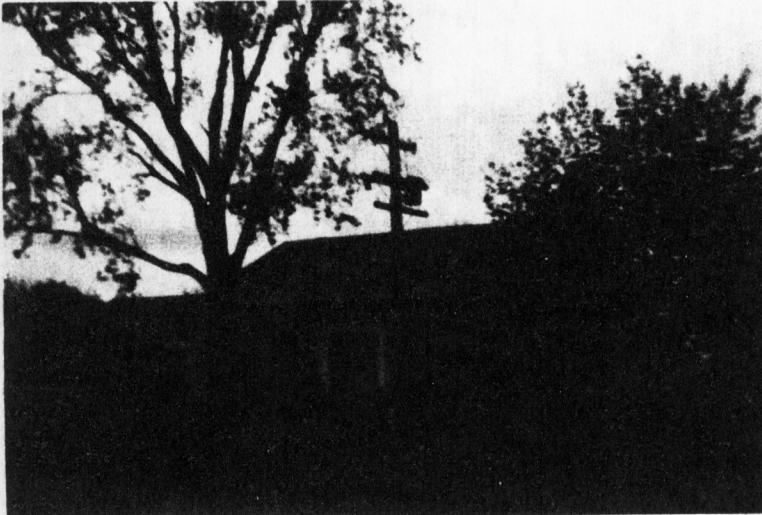
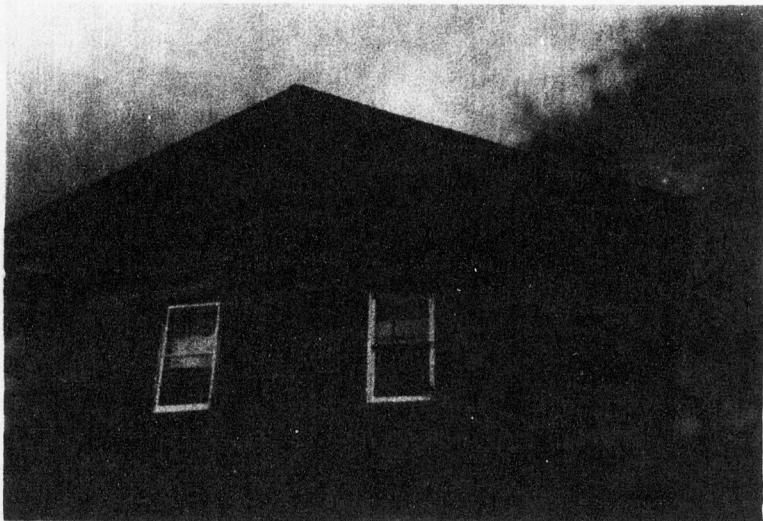
In Hendon Ponds Park, this Greek Revival home (subject #30) is the home of the Park Superintendant. It was originally owned by the Genfield family who sold it to the State Park Commission. There is a wide, full entabliture extending all around the home, and dormer windows in the roof, making full use of the one-and-a-half story height. The portion ^{so} is of heavy Greek Doric style. The arches over the windows and the corner quoins on the main structure are very smooth and perfectly shaped. On the Southern end is a wood-shed-like appendage and then a small lean-to added to that. The masonry here is not so fine as in the main section, but it was presumably part of the original house. In this appendage can be seen the rear end of a Dutch-oven, covered over

on the inside of the kitchen. The front wall of the house is of small more rounded cobbles laid four to twelve-inch to a quoine. #30-2 shows a ~~sidewall~~ replaced when the present fireplace was put in the home (the original having been removed, as in most of these old homes, when "outdated" by stoves). The mason created a very pleasing effect, but his cement was too light colored and his endeavor for horizontality too enthusiastic to blend with the original walls. The back wall of the home has a large sun porch of Greek Revival detail, and in the masonry walls, the stones are nearly flush and there is no V joint in the cement.

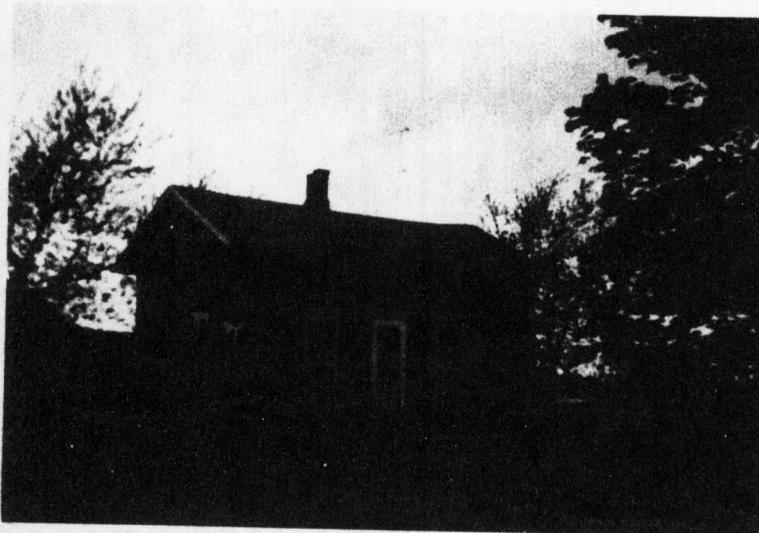
This story-and-a-half home (Subject 31), on Quaker Meeting Road, is made of red and grey cobbles three or four rows to a nine-inch quoine in front and three rows, at the most, on the sides and rear. The ~~arch~~-stone and quoines are of roughly squared, grey limestone. In #31-2 it can be seen that even though many of the rows are of different thicknesses, the horizontal effect is retained by keeping the cobbles, in one row, of corresponding heights; often the color of a row of stone is uniform, also.

In #31-3 it can be seen that the quoines on the rear corners are of varying heights and shapes, because, of a lack of larger stones and a lack of interest in the back appearance of the building.

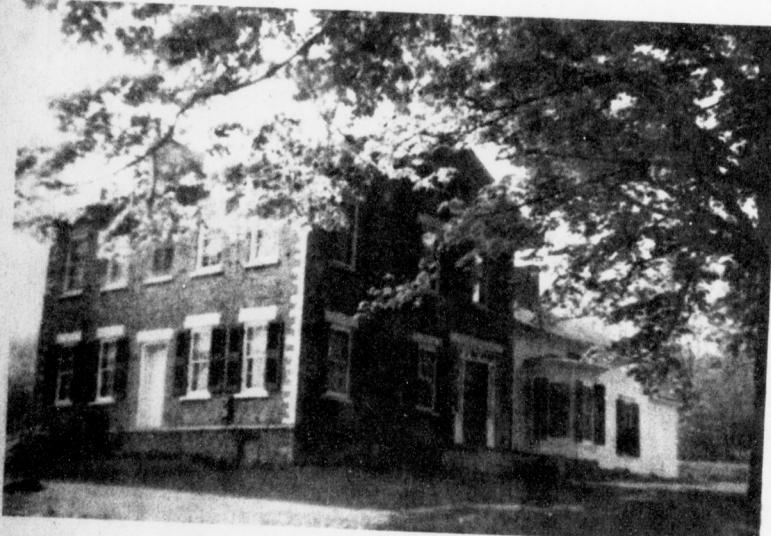
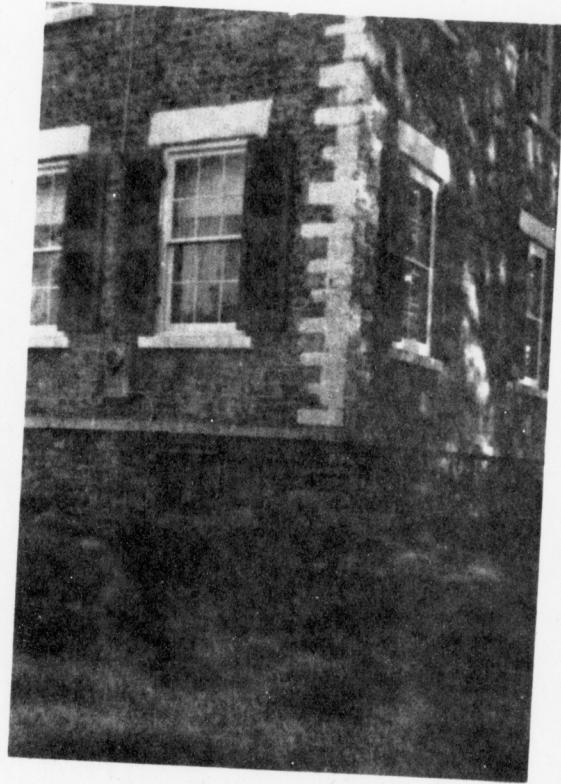
In the village of Mendon, this Post-Colonial home, subject #33, was built in 1883, according to a date carved in an original door. The home has a beautiful front doorway treatment and elliptical attic window-light. The basement is separated from the main vertical element by what appears to be a stone slab sill. Peculiarly, the masonry is finer below the sill than above. Constructed with identical cement, the cobbles are ^{between V Joints made} larger in the foundation section, but are laid with the trowel. Above the sill, the cobbles are smaller, and are set in ~~the~~ horizontal rows, but there is no conscious horizontal joint. The corner quoins are of rough limestone of sizes varying ~~from~~ two to four inches in height. In #33-2 a cobblestone foundation can be seen under the wooden addition, but this has been built out over the original basement wall within the last ten years. This home was built originally for one of the Sheldon family which owned much of the Mendon area after the original Phelps-Gorham purchase.

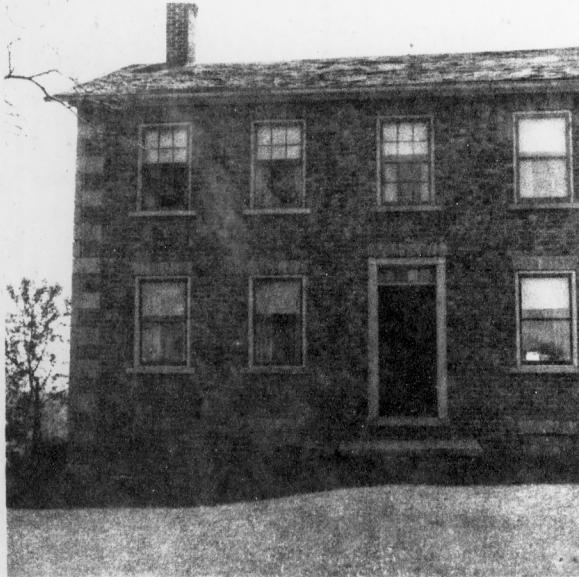
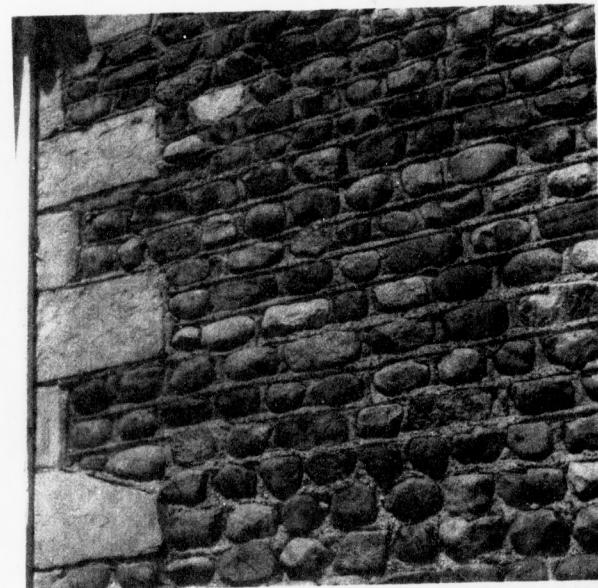
Subject #34, has a central, bisecting hallway, five-bay facade, is two rooms in depth on the left and one large parlor in depth in the right. ~~cement containing much~~
Put together with lime, the front wall is of red, grey, yellow, and tan colored cobbles laid three to four-and-a-half courses to a nine inch quoine. Around the house ~~there are~~ ^{are} trowel-made horizontal V joints and attempts at vertical V joints also. In #34-2 it can be seen that the mason was not so articulate in the rear wall construction as he was in the front; the quoines are often of varying sizes and shapes and larger cobbles were laid two or three, at the most, ~~nows~~ per quoine.

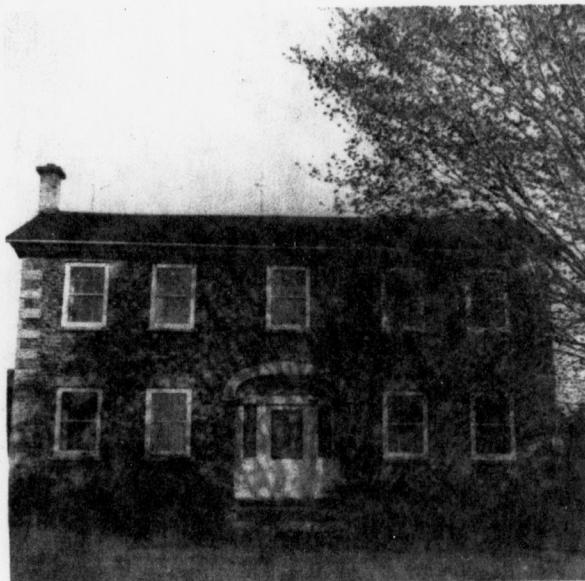
#35.

Subject #35 is quite a pretentious home with a massive doorway and elliptical fanlight. The elliptical arch over the doorway is of solid stone; whereas, over the windows, the arches are of long, flat stones set on end. The cobbles are fairly small in front, set three courses to the quoine in height and laid with a wavy, horizontal V joint and an occasional vertical

pyramidal joint. On the sides, where the masonry has not been replaced, there is still the conscious horizontal and vertical joint attempt, but the stones here are laid only two rows per quoine.

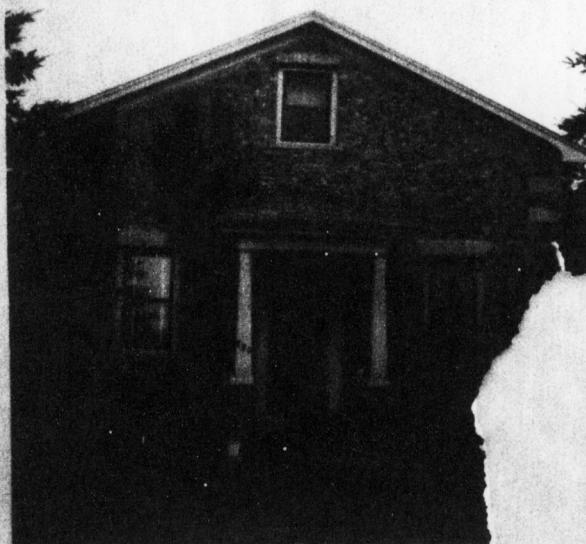
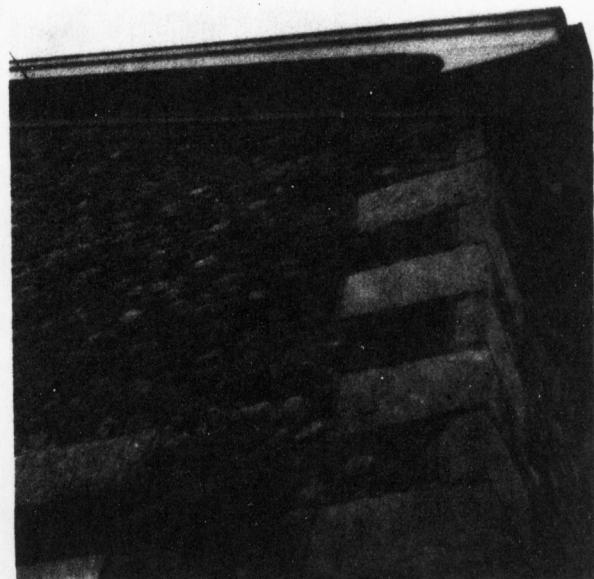
A small, story-and-a-half home, Subject #37 is mostly of red sandstone cobbles laid three to four rows per ten-inch roughly-squared, limestone stones. The arches over the windows are also of roughly-squared, grey limestone. In front there is a conscious effort toward a horizontal trowel-formed V joint, but on the sides and in the rear, there is little.

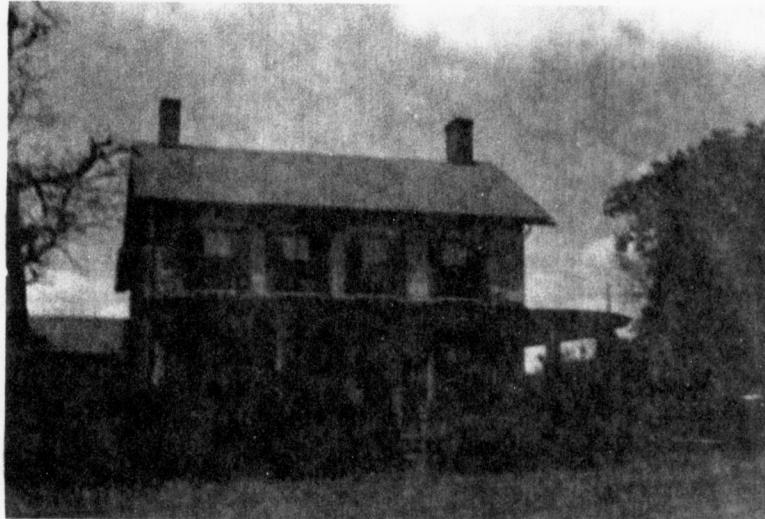
#38-1

Subject #38 is a two-and-a-half story home built very definitely without the porch, which, in the same detail as the addition on the rear, takes up two sides of the building. The cobbles, which were laid three or four rows per quoine around the building, with a wavy V horizontal joint, have been covered with a hideous tan-colored paint. The owner has attempted removal of this defacing, but as yet with no success.

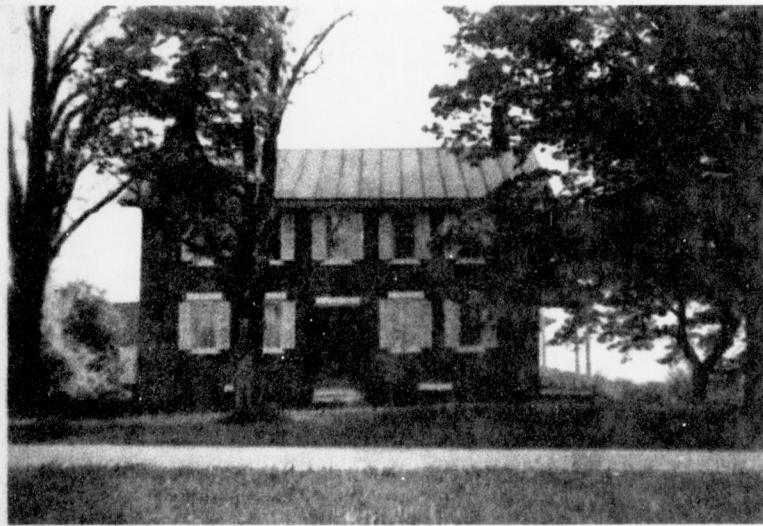
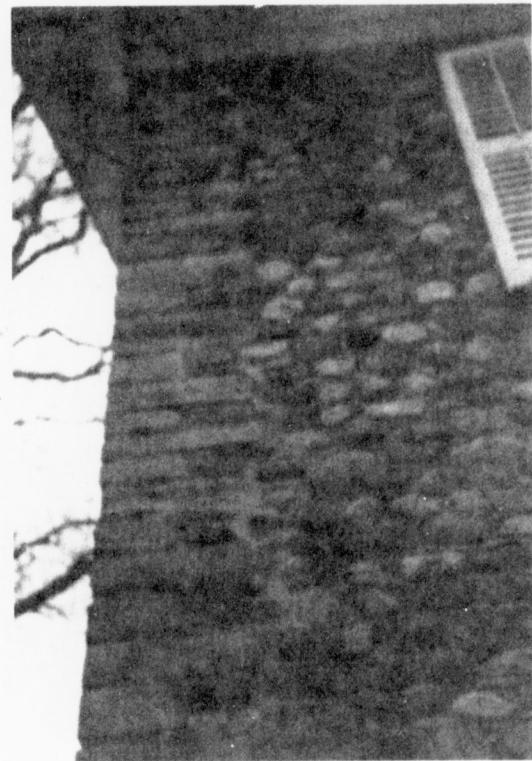
Subject #39, on Mile Square Road, was built in 1832 of all shapes and sizes of cobbles, again, many of red sandstone. Believed built by Scottish Masons, hired by Mason Cole, the quoines are of roughly-squared grey limestone, only two to three inches in height. The cement is crumbly, there is a half-hearted attempt at both horizontal and vertical V joints, and the number of rows per quoine varies between two and three depending upon the height of the quoine.

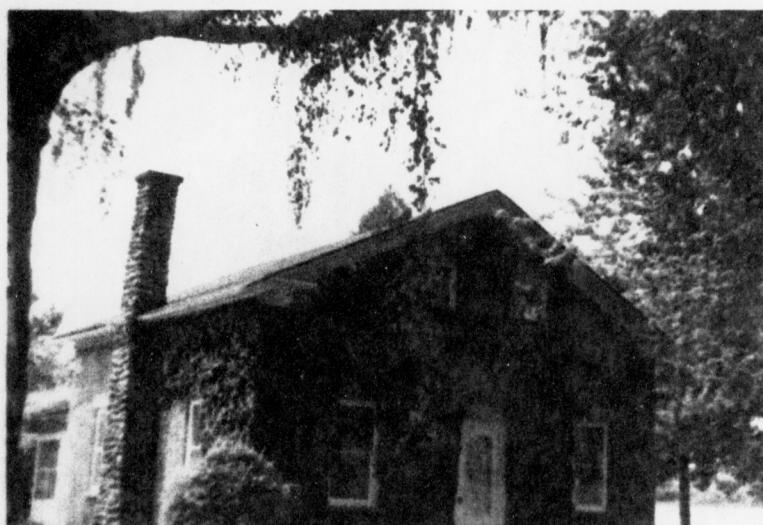
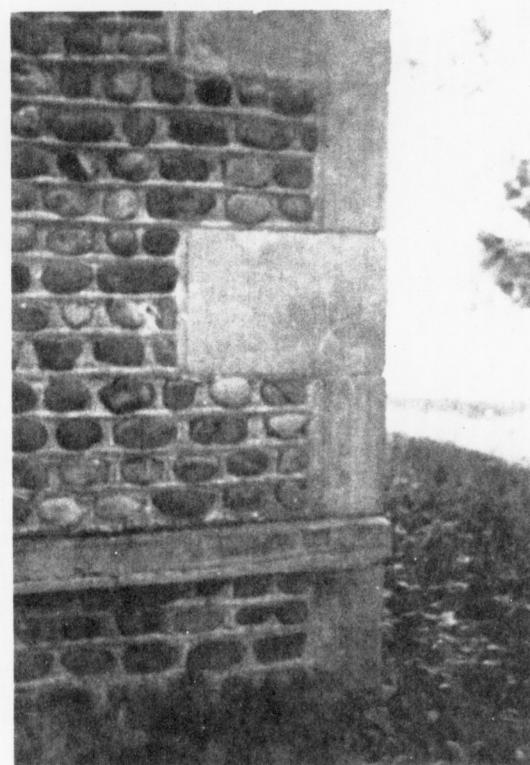
A story-and-a-half home, built by the Whitcomb family and still lived in by a Whitcomb, Subject #40, is another example of a block mass with extension to the rear of cobblestone, as seen in #40-2. Also the house has a stone sill between the basement and first floor level, but here the masonry is identical both above and below the sill. All around the house, the stones are laid four rows to a twelve-inch quoine, in a strong horizontal effect with both horizontal and vertical joints having been moulded with a trowel into a V shape.

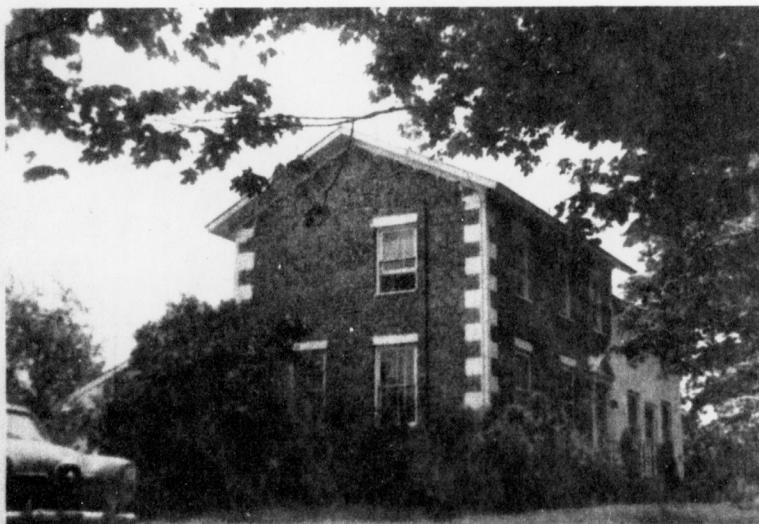
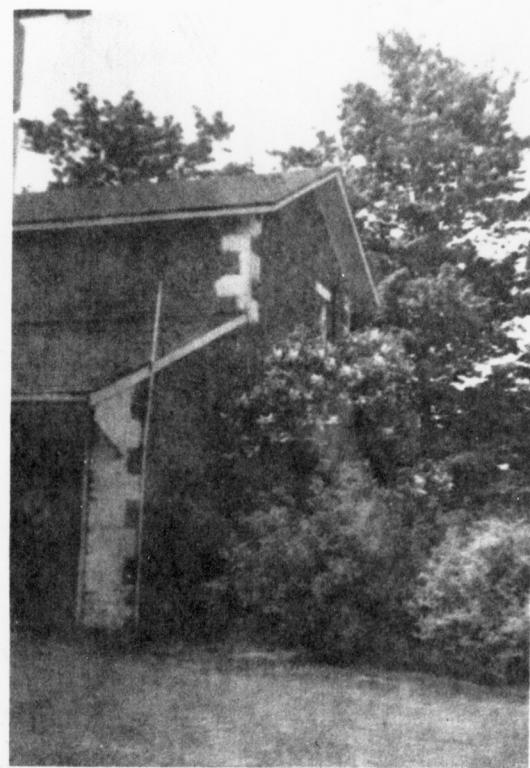
^{the} On Mendon-Pittsford Road, Subject #41 is of block mass construction with a lean-to, cobblestone woodshed on the rear. The masonry is the same all around the house. Used were well-chosen ~~for-size~~ cobbles, of various colors, laid four courses to a smoothly squared quoine. On the right in #41-1 can be seen a brick addition, built of very similar cement to that of the cobblestone section, on a cobblestone foundation with brick quoines.

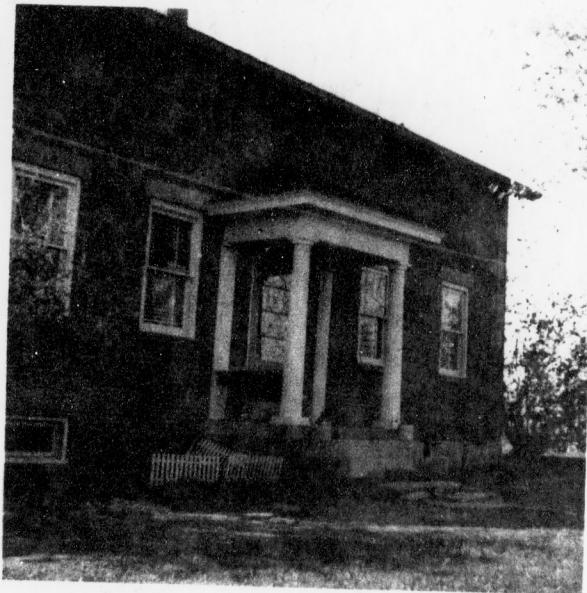
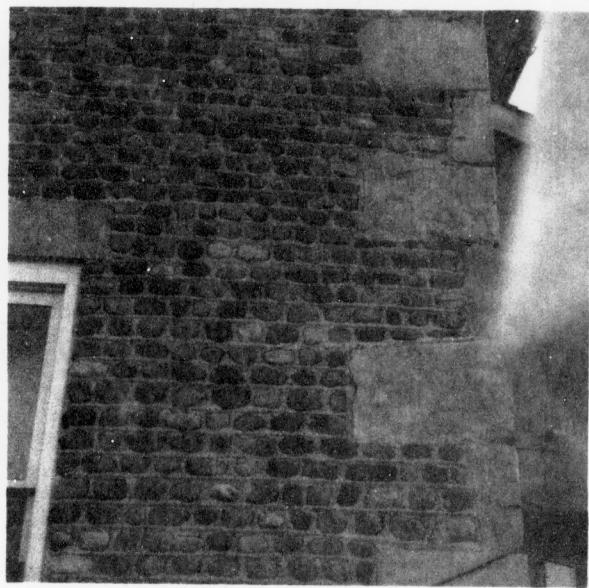
Subject #42 is one of the few homes found in the area where extremely small cobbles of the gravel pit variety were chosen for the front wall. They are laid between almost perfect horizontal V-shaped joints, five courses to a twelve-inch, smoothly-squared corner quoine. On the sides and in the rear, however, the mason was not so particular either in his choice of cobbles or corner stones, and we see very roughly-squared quoines with only four rows of cobbles to each. The small portico on the front definitely classifies the building as of the Greek Revival period.
