A SURVEY OF COBBLESTONE MASONRY
IN THE RUSH - MINDON AREA

submitted by R. B. Wood

May 18, 1955

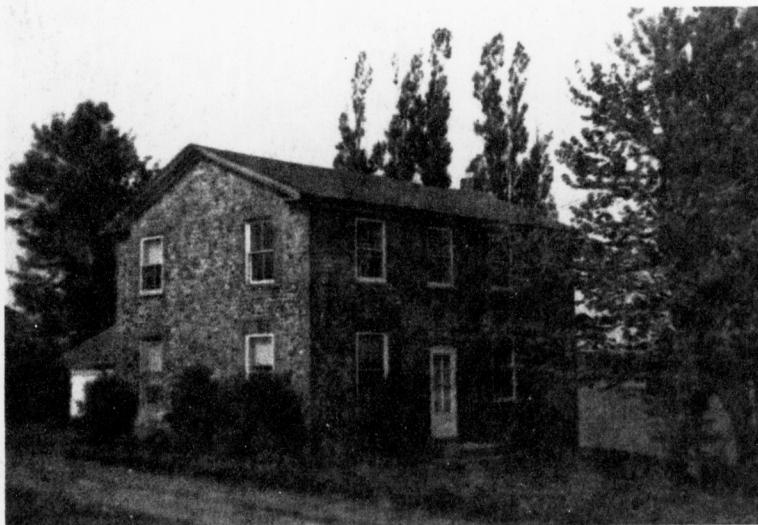
The only home found in the area with brick used extensively to square the corners, Subject #43, had, to me, a very pleasant effect. Not only is the brick ~~laid three in height~~^{used} on the corners to simulate a square stone, but the rounded arch over the door and the flat arches over the windows are of brick; plus, there is a brick quoine effect around each window casing. The cobbles are large, of irregularly shaped and colored varieties laid either two or three rows to a quoine (consisting of three layers of brick).

All over the east side of the structure, shown in #43-2, weathered and extremely aged, black leather thongs hang from the wall. The reason for this I cannot guess. This structure does lie outside the Mendon-Rush area, but upon driving by the home, it seemed like a curious and interesting enough example to warrant its inclusion here.

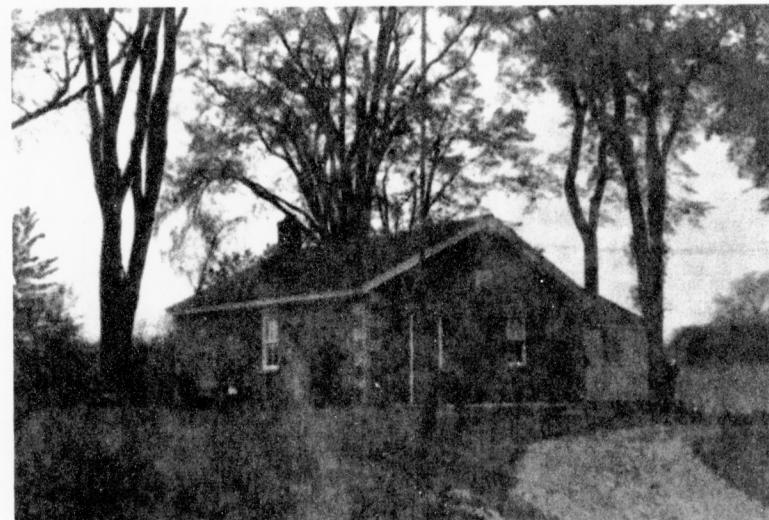
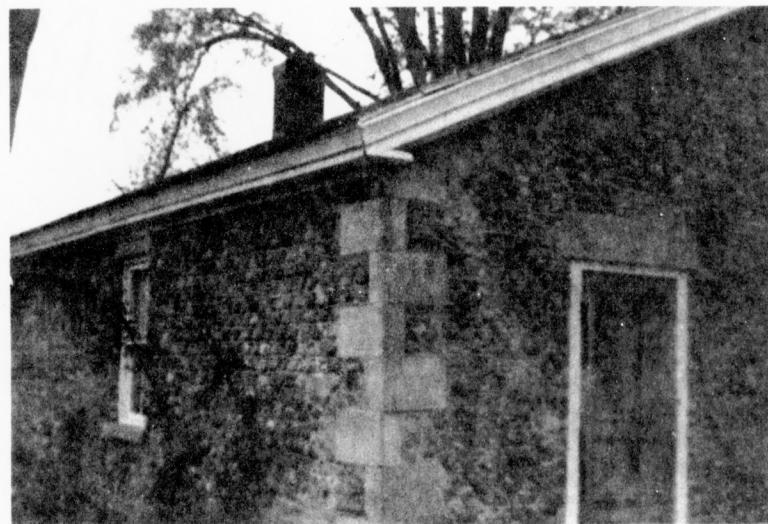
Moving on to the two school houses found in the area, the first, subject #44, a small, probably one-room school, has been refurnished as a small one story home. On the date stone in the upper middle of the front wall, the date 1840 is painted. The stone, used in the corner quoins and the flat arches, is very smoothly-cut grey limestone. The ~~cobbles~~ cobbles in front are smaller than on the side and are laid in sharp horizontal and vertical V joints four and three rows per quoine respectively.

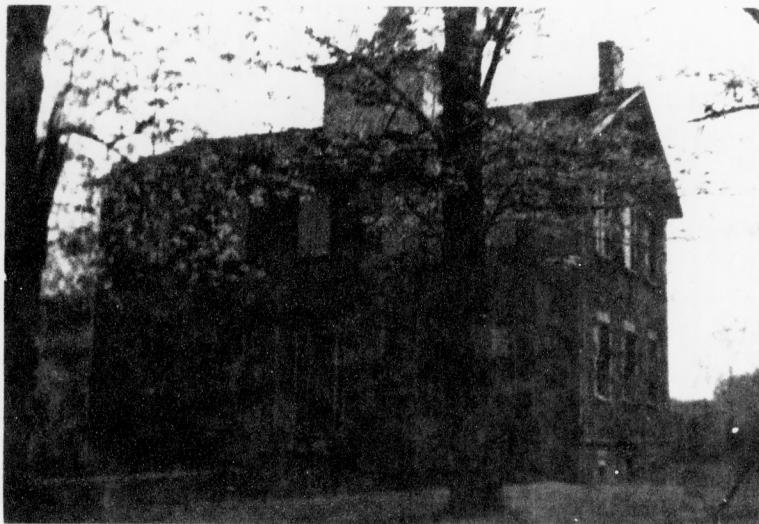
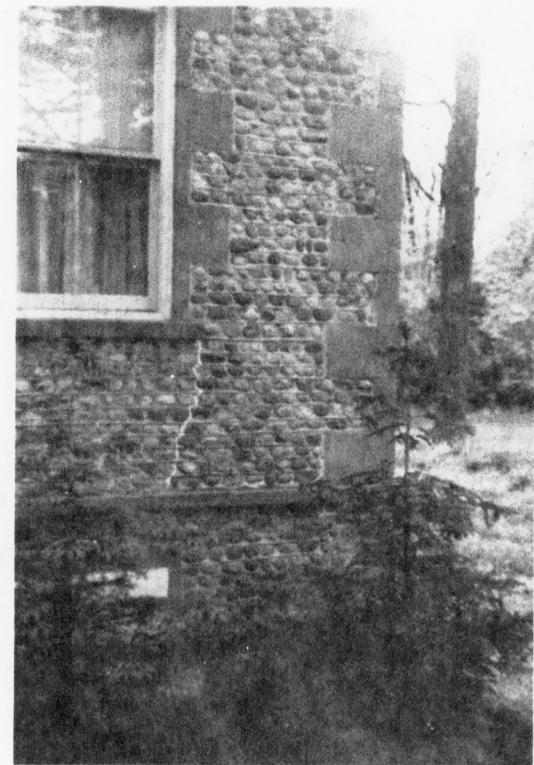
Hendon School District No. 2, subject #45, is a Post-Colonial structure with elliptical arch and fanlight, side window lights, and a cupola on the roof. Now used as a fire hall, an extension has been added very recently to the left in #45-1, of too perfect, modern cobble-stone masonry with an almost mechanical effect. The block mass has a stone, separating sill between basement and first floor which is painted a brown color, as are all the limestone quoines on the corners and around the windows, and the flat limestone arches over the windows. The masonry is the same all around the building, both above and below the sill. Fairly small, rectangular cobbles, with rounded edges, are laid four courses to a quoine in height, with a continued, horizontal V joint and an occasional vertical V or pyramidal joint, all done with the mason's trowel.
