## 16.- WALLINGTON SCHOOL HOUSE

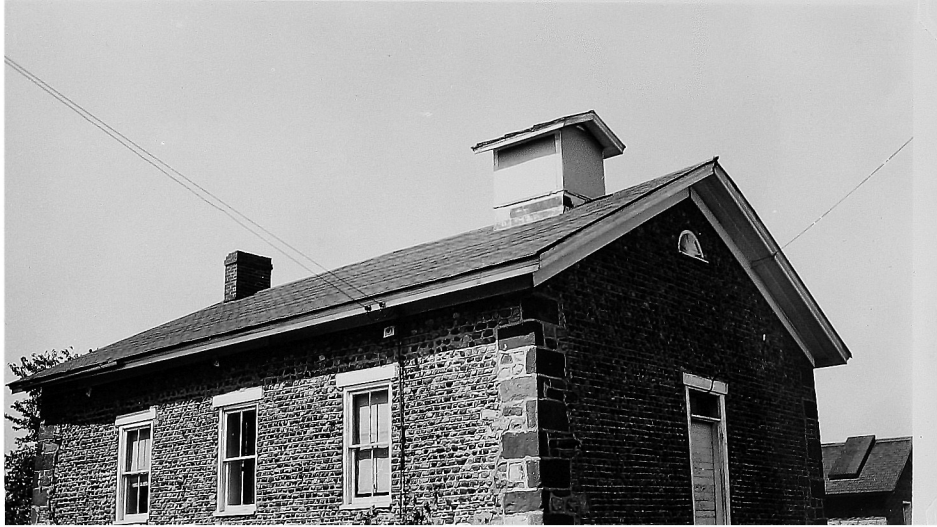
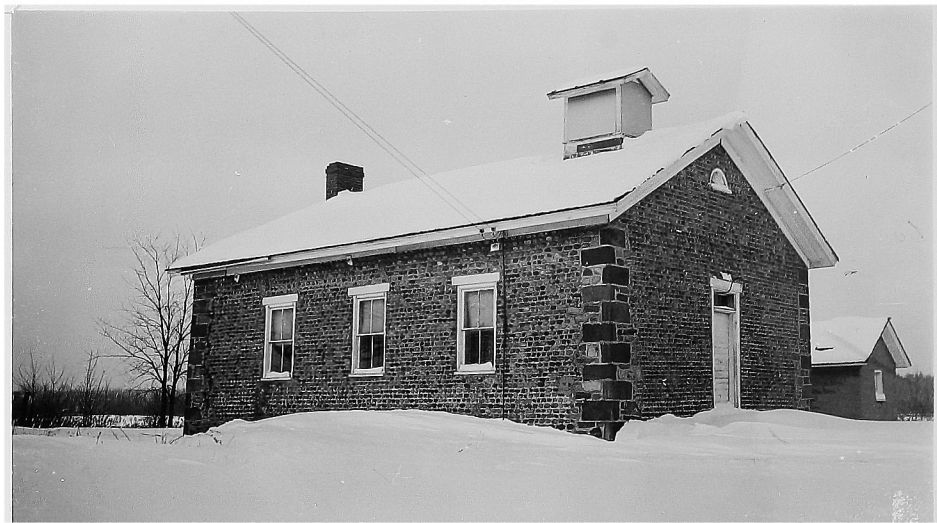
The old Wallington School House on the North Geneva Road is now used as a community center. Unfortunately, the foundation was very poor. Woodchucks have even managed to burrow under it. This has resulted in very bad bulging out of the wall of the back. It has been shored up with concrete.

STONES: The field stones measure  $2\frac{1}{2}$ -4 x  $2$ - $2\frac{1}{2}$  inches.

JOINTS: The horizontal joint is  $\frac{3}{4}$  to  $1\frac{1}{2}$  inch high.

The vertical joints are V's and pyramids.

MORTAR: The mortar is hard with many lime clumps.

QUOINS: The quoins are irregular sandstone.

LINTELS: The lintels are wooden.
