5. ALTON METHODIST CHURCH

This church in Alton is about 120 years old and has been in the Methodist denomination for the entire time.

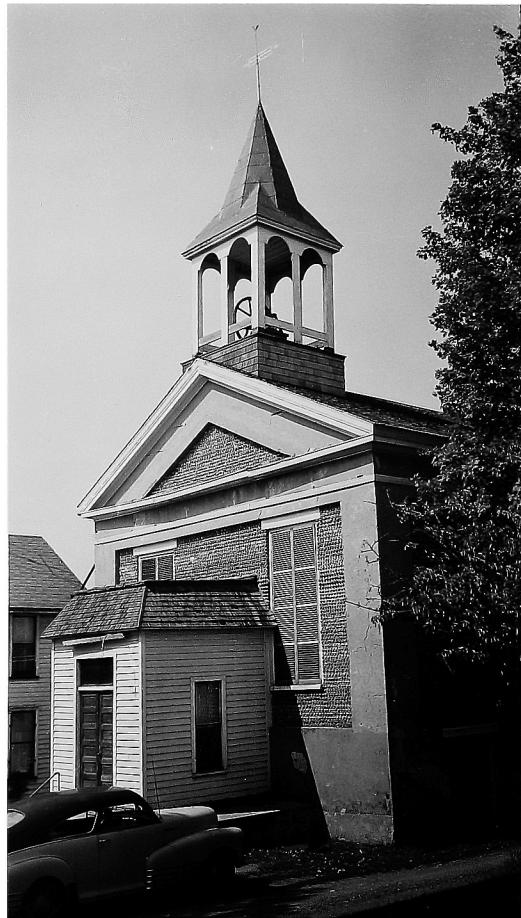
The wide bands of red and white stones are very striking.

STONES: The red lakestones are  $1\frac{1}{2}$ -3 x  $1\frac{1}{2}$ -1  $\frac{3}{4}$  inches.

Courses are  $2\frac{1}{4}$ -2  $\frac{3}{4}$  inches high.

JOINTS: The horizontal V is  $\frac{1}{2}$  to  $\frac{3}{4}$  inches high.

The vertical are V's and pyramids.

MORTAR: The mortar is brown with some pebbles in it.

QUOINS: The quoins are untooled sandstone at the rear where they have not been cemented over.

LINTELS: The lintels are wooden.

Usually these different patterns are arranged in fours, such as in the **Alton Church**: two red, one white, one black. These color bands form definite patterns only on individual houses, not on these houses as a whole. Also, on several homes can be seen more red stones toward the bottom with more white toward the top, or vice versa. Many masons also seemed to favor stones of either brown, black, or yellow hue, or a mixture of these.
