**Genealogy of a Cobblestone House**  
4625 Lewis Road, Walworth  
Wayne County, New York 14568 (2009)  
Ron and Juanita Matteson, owners

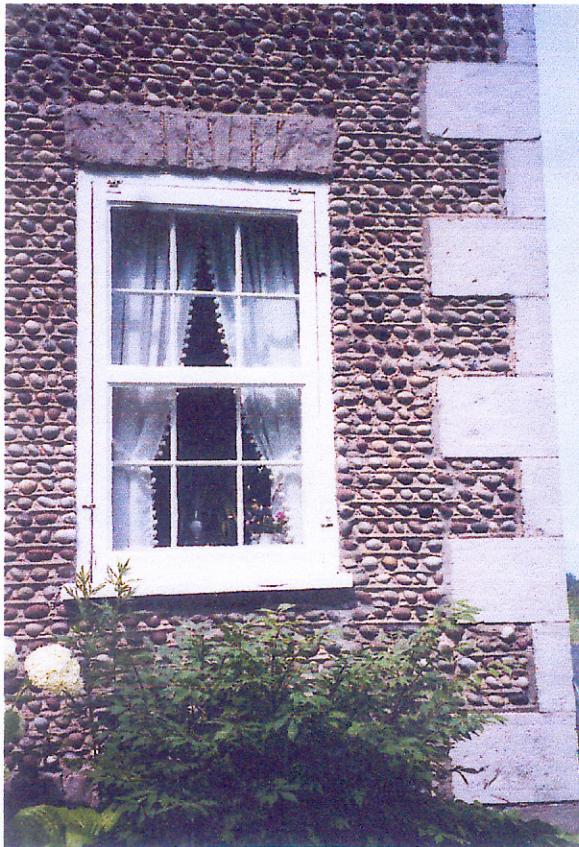
Figure 1. Stone construction

Cobblestones could be gathered from fields or the shores of the Great Lakes. The stones from both places have been smoothed by ancient lakes covering northern New York, and the current Great Lakes continue the process. The stones recovered from the shores of the current Great Lakes are of a better quality, having endured the finishing process for longer periods of time. We have been told that it was a two-day excursion to gather lake-washed stones to build a cobblestone house. One scenario is that men (and boys) would take the horse-drawn wagon north to Lake Ontario (about 8 miles up what is now Route 350). They would gather stones for the rest of the day, and spend the night there. The next morning they would finish filling the wagon with stones and travel back to the construction site. Sometimes it would take as long as three years of multiple repetitions of this routine to collect enough stones to allow building to proceed. It has also been said that three houses were usually built at the same time; the workmen would then rotate around the three houses, allowing for time for the lime-based mortar to set properly at each house before coming back to it. Figures 1 and 2 show some close-up views of the cobblestone construction.

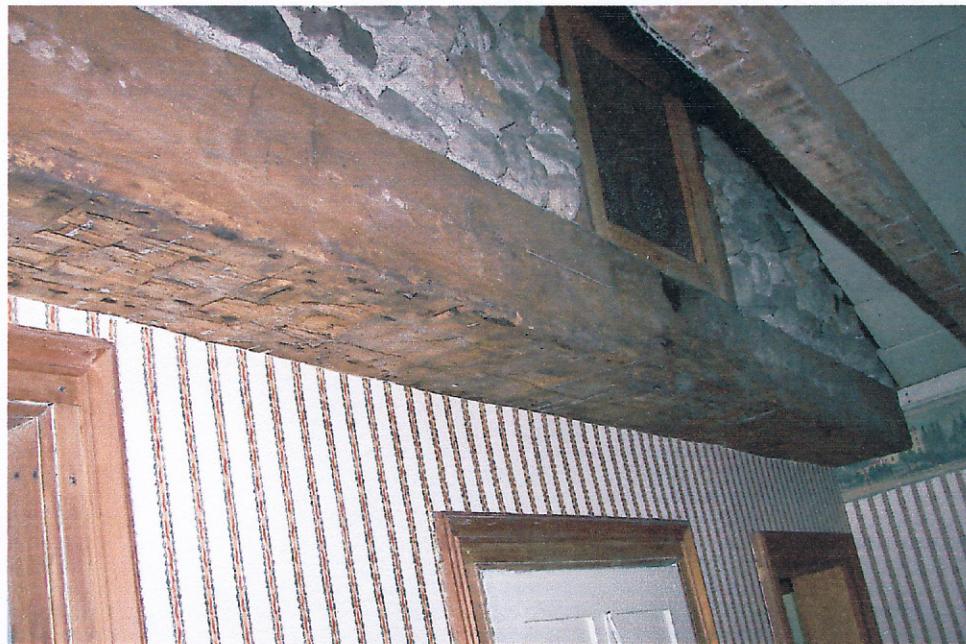
Figure 3. Beam in current dining room

Helpful information about the construction of the house was discerned by Mr. Ken Artl, a certified cobblestone mason, who was asked to inspect the premises on April 3, 2009. His inspection was what led to the conclusion that the cobblestone structure was built in two stages. The first stage was the building of a one-story barn with a large door all along the north side of the building. A huge, very strong hemlock beam crosses the north wall of our dining room to indicate that it was the top of the large barn door frame, and that our dining room was at first a barn. Figures 3 and 4 show this beam as it exists in our current dining room. The “barn” was made with a crude form of cobblestones, large and uneven, still visible on the south wall of the house. We have seen references in the census records and plat maps that there was a blacksmith shop near this location, and this barn was probably the shop! As a matter of fact, the last person I could find in the chain of deeds for the property was Clair Warren, with an occupation listed for him of “blacksmith” in the 1880 US census.

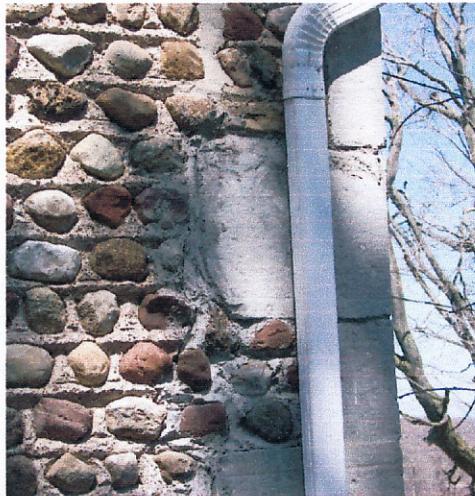
Figure 5. SE Corner of Dining Room  
(former blacksmith shop)

The rest of the cobblestone house was built to be more elaborate, using smaller cobbles in a more orderly fashion. It was probably added around 1837, and joined to the blacksmith shop. At the time of building the addition, the east wall of the barn (front of house) was resurfaced with smaller stones to better match the “new” part of the cobblestone house. You can see the

difference in construction by looking at Figures 5 and 6. The living room wall is made with smaller stones of better quality than the dining room (former blacksmith shop). The quoins on the front of the dining room look like they have been replaced with new quoins, and the old quoins have been used in other places on the rear corners of the two-story new part of the house. This is where one of the old quoins was discovered to have the date of 1837.

Cobbles on the front of the blacksmith shop are 2.5" with a v-shaped horizontal mortar joint between courses, and 4 courses per quoin. Cobbles on the south side of this section are large, at least 3" in diameter, but still 4 courses per quoin.

Quoins at all three corners on the front of the house are cut stone, tooled to make patterned edges and sides. Quoins on the back corners are cruder, darker in shade, and not tooled, another indication that the house was built in two stages. These crude quoins were probably salvaged from the blacksmith shop during the addition.

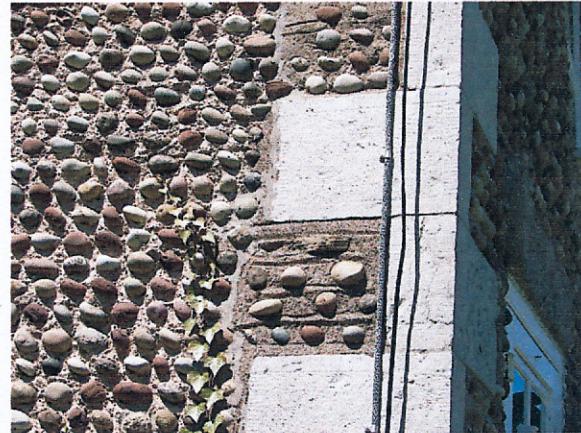
Figure 6. SE Corner of Living Room

Cobbles on the front (east) side of the two-story wing are 1.5" in diameter, with 5 courses per quoin. Cobbles on the north side of this wing are 2.5", 4 courses per quoin.

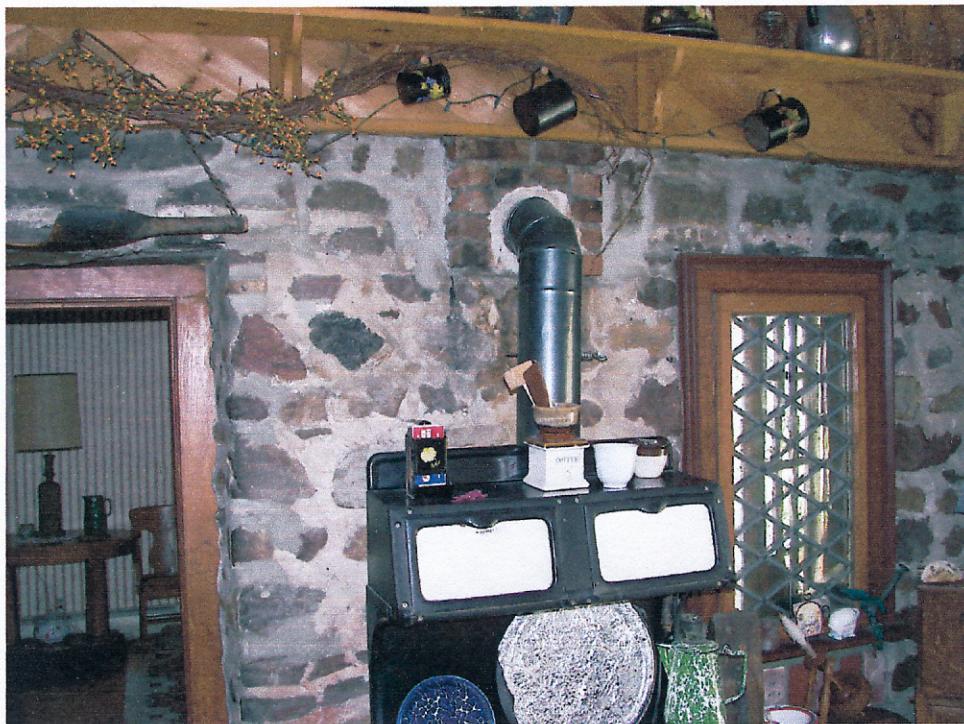
Figure 7. Rear wall of old blacksmith shop (now an interior wall of the current keeping room).

It is hard to tell the differences between the rear of the 2-story wing and the rear of the blacksmith shop, but you can almost see a seam between the two sections. Large flat stones (10-15" in diameter) were used as the facing on the rear wall. Figure 7 shows the exterior or the blacksmith rear wall, in its modern reincarnation as a kitchen. A partial view of the current dining room (old blacksmith shop) can be seen through the doorway.

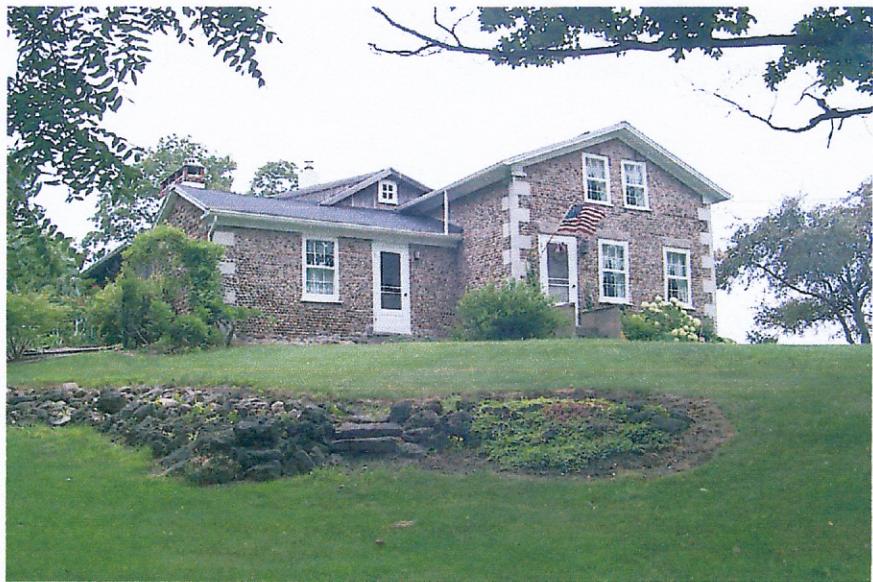
Figure 8. Present view of cobblestone house, front view (2009 photo)

The front view of this house, facing east, as it looks now (2009) is shown in Figure 8. Another picture is shown in Figure 9, taken around 1941. The house looks very much the same

in the two pictures taken 68 years apart, with four exceptions: There are no rain gutters showing in the older photo. The shrubs are higher. The storm windows and doors have been added or changed since 1941. The addition that we added to the rear of the house shows up as a peak in the center of Figure 8. June Swadling Foote indicated that the ivy growing on the front of the house was a big nuisance, and threatened to come in the second story windows. They had to pull it down periodically, as do we.

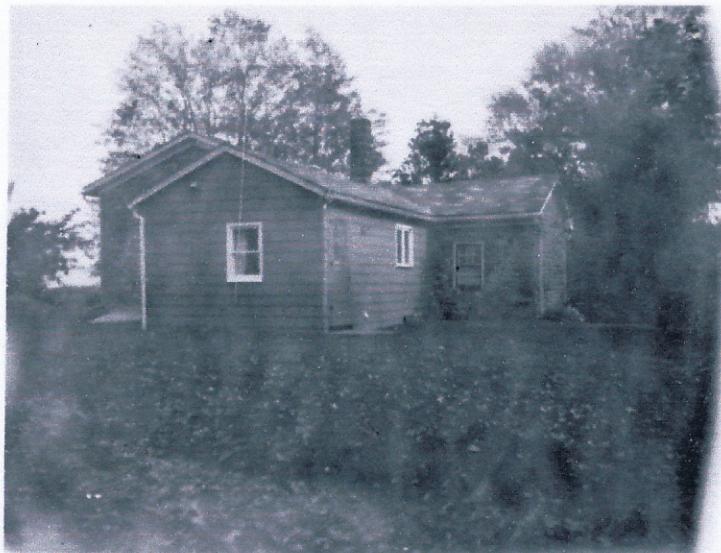
Figure 11. Old wing, looking from the southwest

Owners previous to the Swadlings had built a wood-frame addition on the back of the house that contained the kitchen, bathroom, and small bedroom (Figures 11 and 12). The initial location of the rear door of the house was at the west end of the addition. Mr. Swadling moved it to the south side.

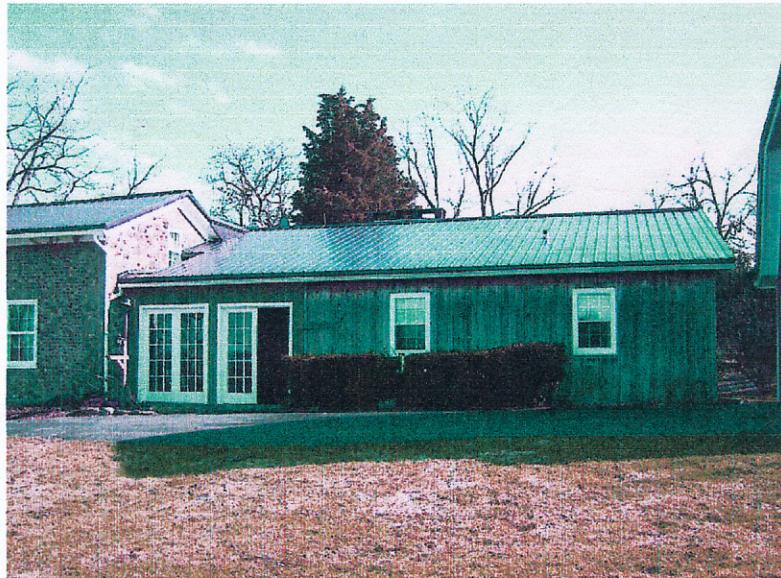
Figure 13. New wood frame wing on west side of house

- A large second basement was excavated as a foundation for a new larger wing.
- The new wing was added, shown in Figure 13, with kitchen, keeping room, two bedrooms and bathroom with both a shower and a bathtub (found left in the old basement, which still housed the oil furnace). The new wing also has a loft for additional sleeping space, and a utility room for laundry. A second stairway to the basements is accessible from the laundry room. Solid oak floors were used in the new wing to be compatible with the rest of the house.
- Electric and plumbing facilities were added for the above, including a sump pump in the new basement, and a septic tank and leach bed for the new bathroom.
- The oil-based heating system was extended to add new hot water zones to heat the new rooms.

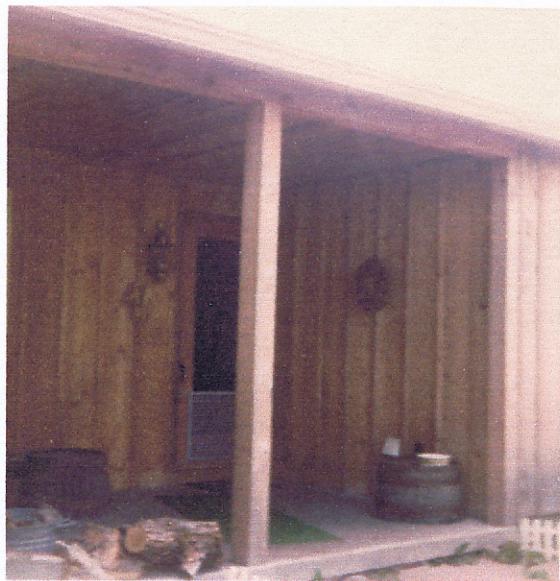
Figure 14. North entrance before enclosing

- An enclosed side porch was added to protect the north entrance to the new wing (Figures 14 and 15).
- An enclosed solar room was added on the south side of the new wing (Figure 16).
- The oil furnace was replaced with a new one.
- A central air conditioning system was installed, with central electric heat capability.
