24-CHARLES HOAGLAND PLACE

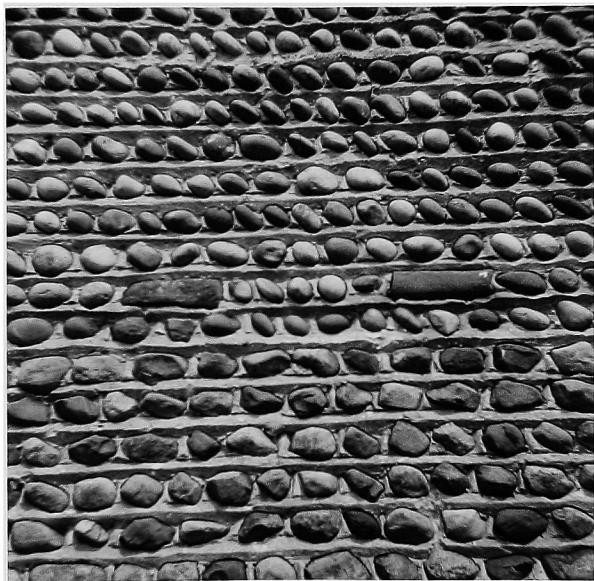
Lake-washed cobblestones on top half of the picture and field cobblestones on bottom half. Also, note the anchoring stones in the center of the picture. The Charles Hoagland house in Williamson Township.

On one of my trips I was told that the masons used a few large stones placed at intervals along one course which passed straight through the wall, not only to tie in the veneer of small stones but also to be used as a scaffold holder. It seems reasonable that they could be used for scaffold riggings because of their parallel position and the force they could withstand. A good example of these tie-in stones may be seen in the front of the Hanagan Place. Check the Appendix for a picture of two of these stones found in a wall of the Hoagland House.
