Giant Erie Canal rupture turned hamlet into lake

OVERLOOKED ORLEANS: Crews worked intensely to repair breach

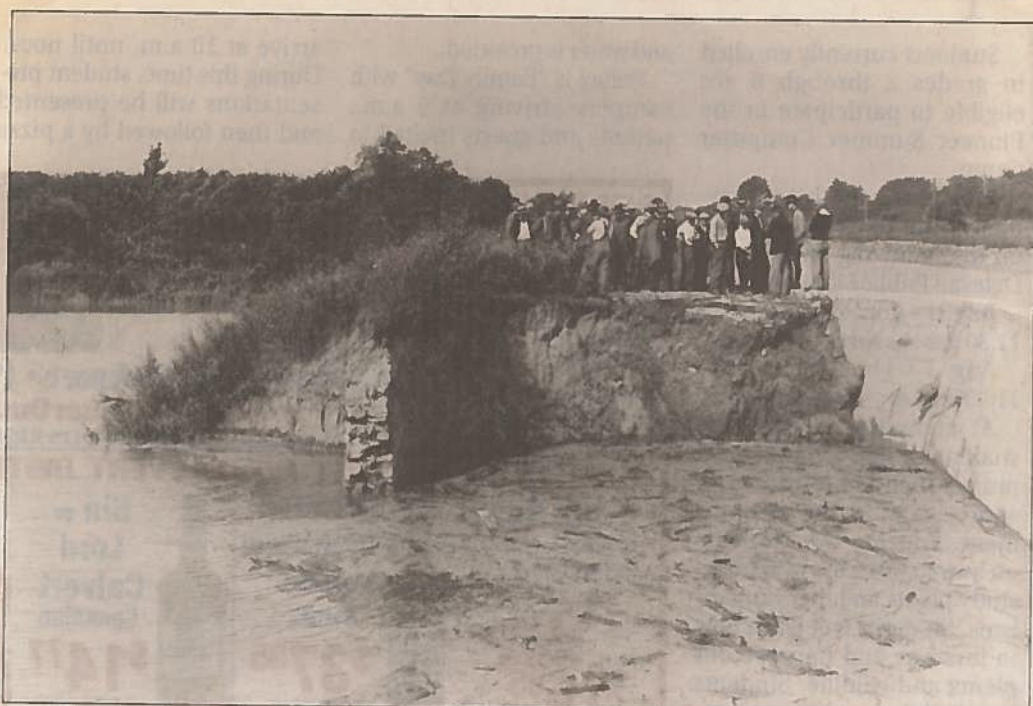
SUBMITTED PHOTO

Workers survey the damage after the Erie Canal sustained a major breach near Eagle Harbor. Intensive work was needed to repair the canal quickly.

Several photographs, taken in August 1927, show the damage sustained during an extensive break in the canal wall near Eagle Harbor.

On Aug. 3, 1927, local farmers observed a slight leak in the south wall of the canal near the Otter Creek gully. L. E. Bennett reported seeing a three-foot square hole open up, spilling thousands of gallons of water out of the waterway in a matter of minutes.

The initial opening formed approximately 100 feet west of the Otter Creek culvert. Within a relatively short period of time, the flooring of the canal gave way and the south wall broke free, creating a hole that spanned 50 feet in length and 7 feet in height.

More than 250 men were hired to work night and day in an effort to expedite the repairs. More than 20 trucks, six steam shovels, and other pieces of power equipment were utilized to hasten the project.

Within two weeks the majority of work was complete, resulting in the laying off of 150 workers who were employed with the carpentry gang.
