# Canal break of 1927

BY C.W. LATTIN  
Orleans County historian

Vol. XXXIII, No. 23  
**Bethinking  
of Olde  
Orleans**

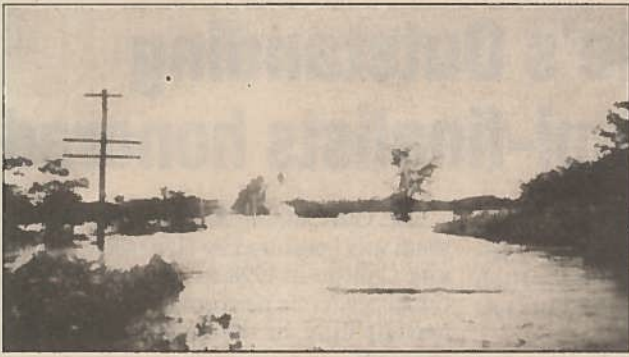
CONTRIBUTED PHOTO

This photo, which was taken shortly after the water had started to subside, shows Albion-Eagle Harbor Road looking west at the Otter Creek gully east of Eagle

Harbor. The house of “Skinny” Porter in the distance and another house next to it were under water up to the second floors. The residents of these marooned houses were rescued after spending a night in the upper rooms.

A large piece of concrete which plunged down blocked the southern opening of the culvert through which Otter Creek flows. Within minutes, water started backing up Otter Creek, which in turn flooded hundreds of acres of fertile land to the south.

It was believed that muskrats digging in the canal embankment caused the leak, which grew bigger and bigger by the pressure of the water.

More than 100 feet of the canal embankment was washed away in the disaster. It took more than 100 workmen with steam shovels, electrically operated concrete mixers, pile drivers, other machines and six weeks of steady labor to repair the canal bank.
