Cobblestone Buildings in Seneca County

This article was written by Walter Gable, the Seneca County Historian, and revised on June 9, 2006.

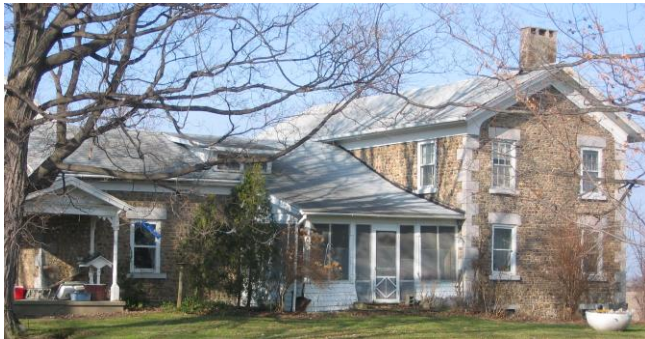
The Woodworth Cobblestone House, 936 East Tyre Road, town of Tyre, was built in 1844. It consists of a two-story main section with a one-and-a-half story wing to the west side. The basement has a fieldstone foundation and an old curved brick baking oven built into the chimney. The walls are a foot and a half thick and the cobbles themselves are random in color and size.³

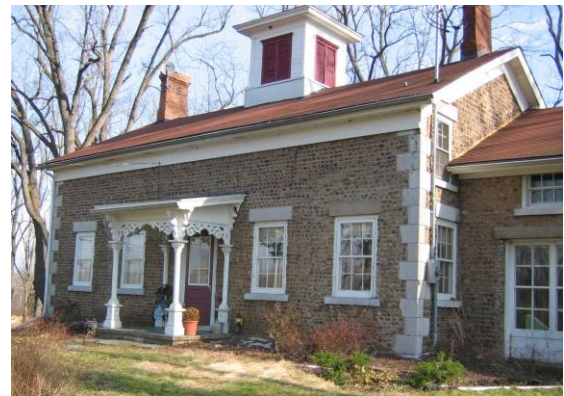
The Lay Cobblestone House, 1175 Old School House Road, town of Tyre, was built by Hiram Lay. The cobblestone barn just across the road to the north was demolished when the Montezuma Wildlife Refuge acquired the property. The cupola from the barn was then placed on the roof of the house itself. The one-story porch at the entryway adds a Victorian note to the front of the house. There is a brick smokehouse on the rear slope, and the house has an original bake oven built into an inside chimney wall.⁴

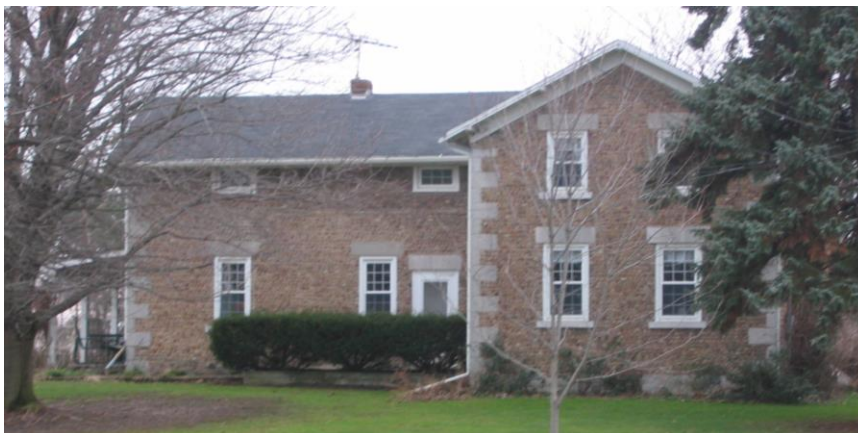
The Seekell Cobblestone House, 1262 Gravel Road, town of Tyre, was built by early residents named Seekell. The house has wide floorboards, hand-cut beams, and hand-laid foundations. The old door at the original front of the house has nine panes. Once a double house, it has an

open stair at one side of the house and closed and curved stair at the opposite end. Since the house was constructed in two phases, there are many walls now inside that were originally outside. An unusual feature of the windows is the trim on the inside of the windows which tapers inward as it approaches the ceiling, so that the sill or lower part measures thirty inches but the windows narrow to twenty-four inches at the top.⁵

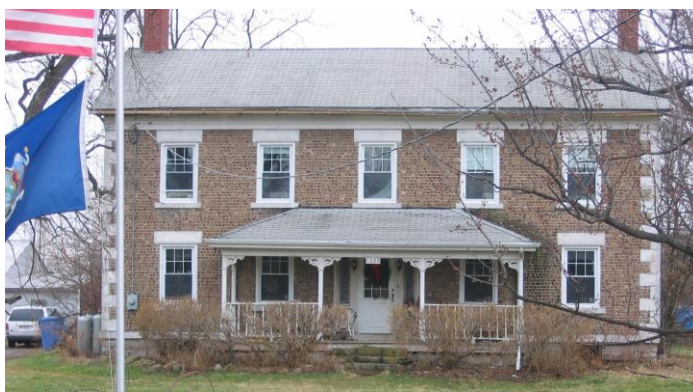
The two-story five bay cobblestone house at 1229 Birdsey Road, town of Junius, was built in the 1830s or 1840s of Federal style. It perfectly illustrates typical construction methods of the time, and was built by three different workmen. The back was done by an apprentice, with large stones set in lines, which were far from straight. A journeyman then built the sides, with smaller stones and straighter courses. Then the master mason would

build the front of the house using the smallest stones and presenting the house's most pleasing face to the road. There is a dirt floor in the basement, which once had a baking oven as part of the fireplace system, and twin chimneys on the north and south sides. The house has walls twenty-four inches thick. There is a hand-dug well, a milk house, and two barns.

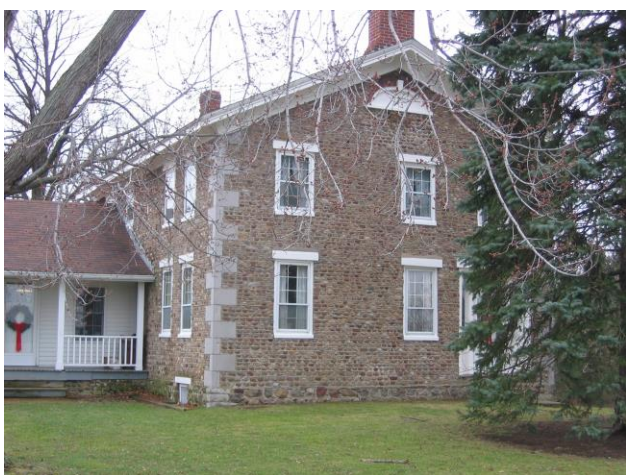
The Graves Cobblestone House, 1370 Route 318, town of Junius, was built by John Graves in 1837. The two story, three bay house has four rooms downstairs and three rooms and a bath upstairs, with an open staircase to the second floor and a fireplace in the parlor. A wide overhang is formed by the roof and fan windows in the gables.⁶

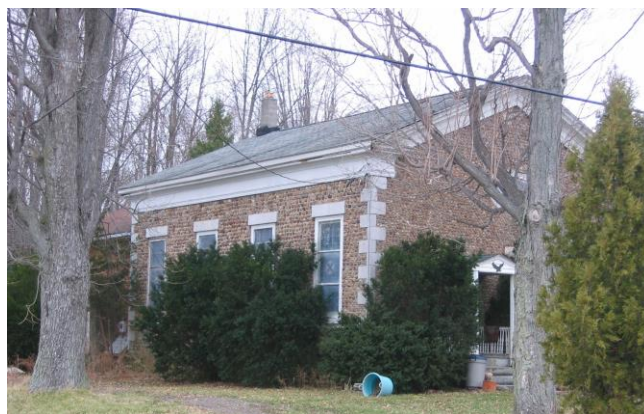
A cobblestone church can be found at the corner of Stone Church Road and Route 318, town of Junius. This building was constructed in 1839 as a Methodist Episcopal Church. It has a wide entablature and small returns, with a large oval stained glass window on the gable end. There was once a wooden porch that extended across the front of the church, which had wooden

steps on all three sides. The building served as a church until 1969, when it became a private home.⁷

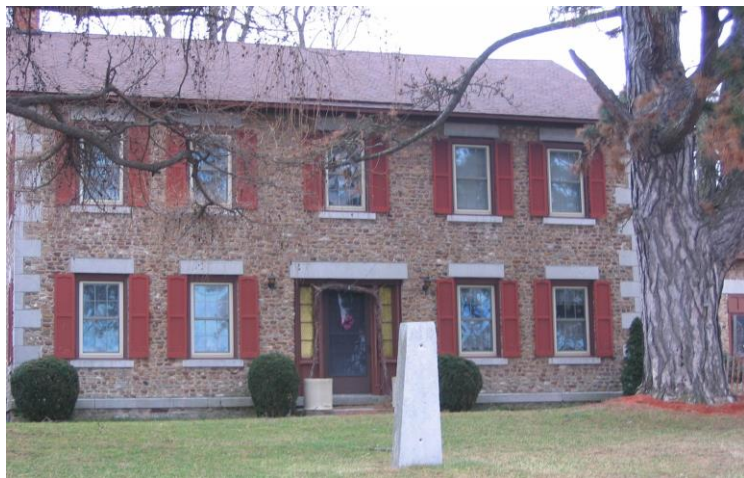
The Holmes House at 1111 Stone Church Road, town of Junius, is Federal style and was built of stones from nearby fields between 1820 and 1824. It is five bays wide and has a long cobblestone addition stretching to the south. All of the windows have stone lintels and sills, the lintels being 10.5 inches thick and the sills 4.5 inches. The courses of the house are four to the quoin, except for those on the north wall of the house and the south wall of the

wing where they are three courses to the quoin. All the quoins are made of squared limestone. There are two fireplaces in this house: a brick fireplace in the family room and a stone fireplace in the living room. Downstairs are seven rooms and a full bath; upstairs are four rooms, and a bathroom. The basement is the same size as the house and a former owner kept his cattle there.⁸

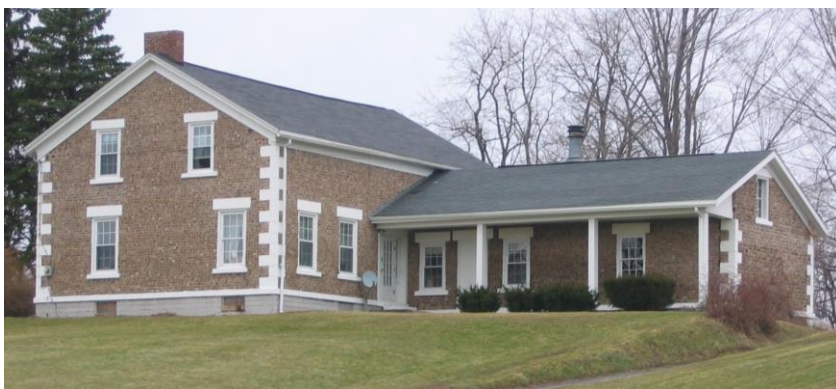
The Gassner Farm cobblestone house at 1079 Stone Church Road, town of Junius, was built in the 1830s-1840s in the Federal style. Because it so closely resembles another cobblestone on the same road to the south, it may have had the same builder. A local resident who lived here as a child reports that the wing projecting to the south housed a wood shed and the wooden door in the upper section of this gable served as the opening where wood was thrown in. For many years the basement was dirt-floored to help keep cool the food stored there.⁹

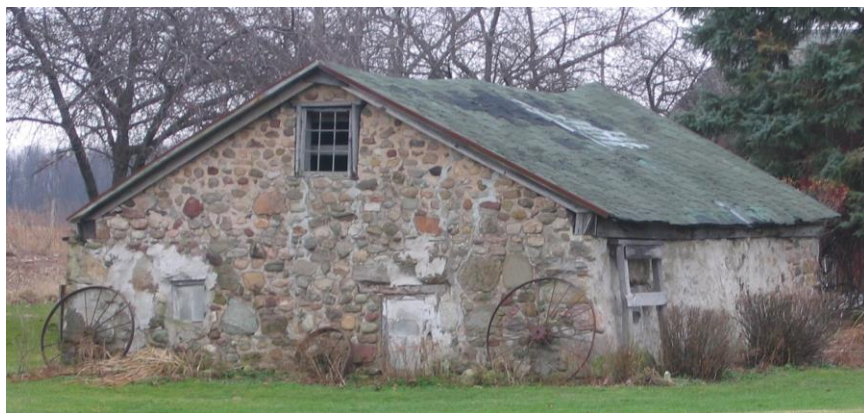
The stone barn at 465 Garrett Road, town of Junius, was built by the Lundy family and is one of the few stone barns still existing in Seneca County. The barn was originally used for hogs which went in and out of the small door. The barn has

additional interest because of the extreme variation in color and size of its stones, ranging from cobbles to bounders, all probably collected from the area. The small door has a heavy wooden beam for a lintel and another heavy wooden beam supports the roof.¹⁰

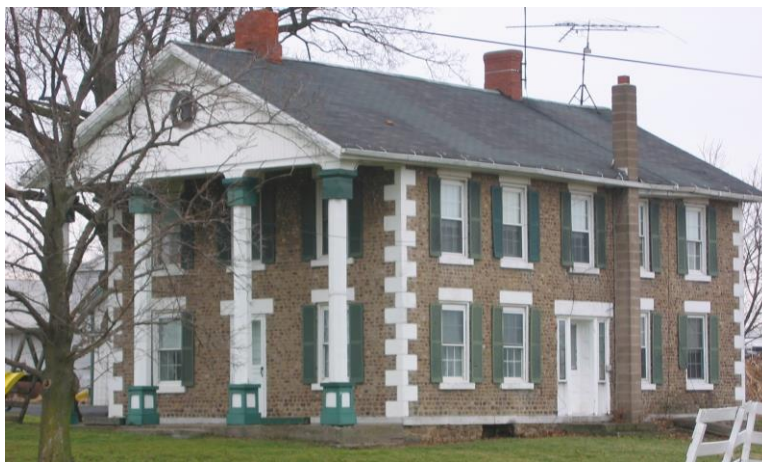
The Carman Cobblestone House, 533 Dublin Road, town of Junius, was built in the Greek Revival style in the 1840s or 1850s. One of the largest in the county, it has a bell on the roof housed in a cobblestone addition. The classical front columns are set on square bases of a different color. An unusual round window in the large pediment faces the road. The house was built by John Carman.¹¹

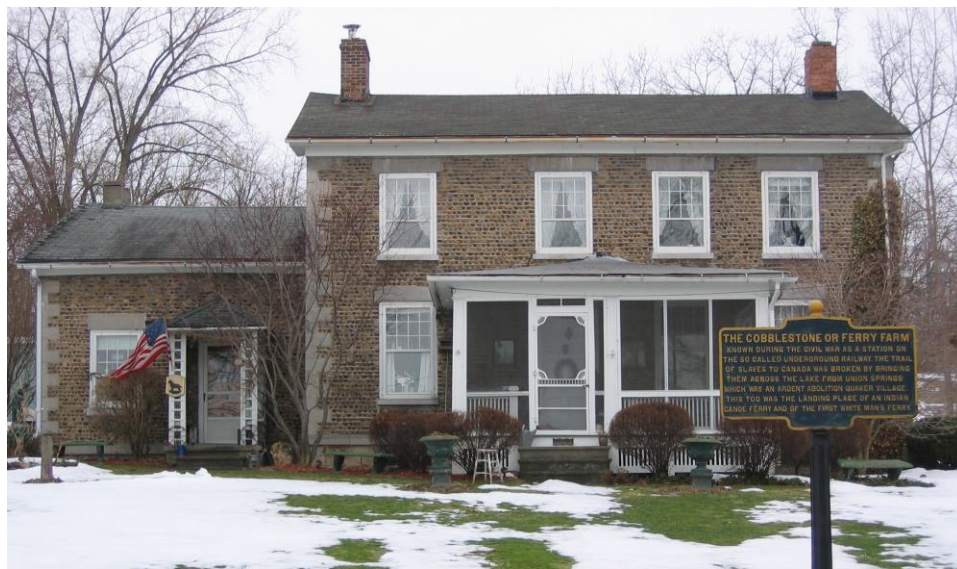
The Ferry Farm Cobblestone House, 2523 Lower Lake Road, town of Seneca Falls, was constructed in 1830 by Julius Bull and faces Cayuga Lake. Both this house and its property have had an interesting history. The first ferry across Cayuga Lake was operated from a landing here, until a bridge was

constructed in 1800. Originally the house was used as a tavern, and it is locally believed to have served as a station on the Underground Railroad. A symmetrical, five bay house built in the Federal style, it has stone lintels and sills, and there is a semi-elliptical fan window in each of the two gables of the main wing.¹²

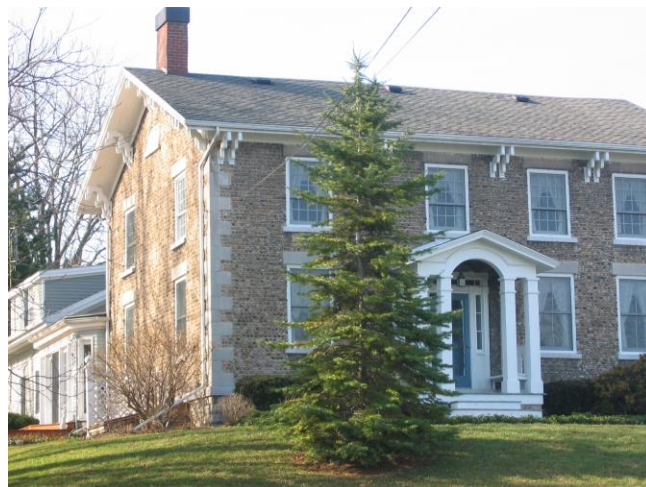
A cobblestone house at 5102 Route 89, town of Varick, was built by Julius Bull in 1833. A simple rectangular building, it has four downstairs rooms with a central hall and four rooms upstairs. In the 1980s, the George Souhan family added an extensive three-bedroom wing to the west and an outdoor patio to the south. Three well-preserved barns remain from an earlier time, as does the boathouse across the road.¹³

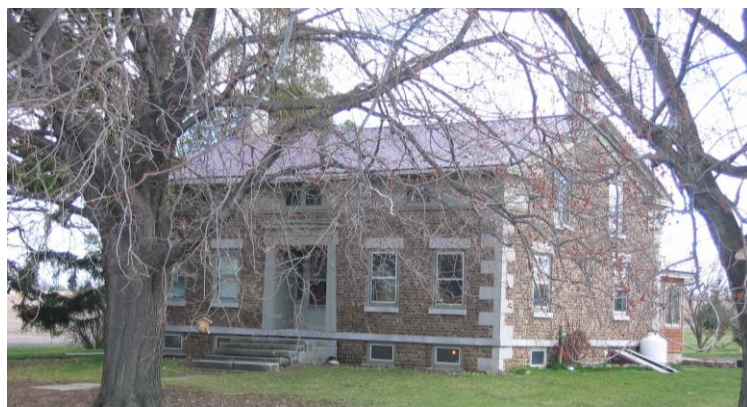
This house is located at 3333 Ritter Road (corner of Aunkst Road) in Waterloo. Note carefully the beautiful quoins and the watersill. Also note the indented front entry door and the frieze windows.

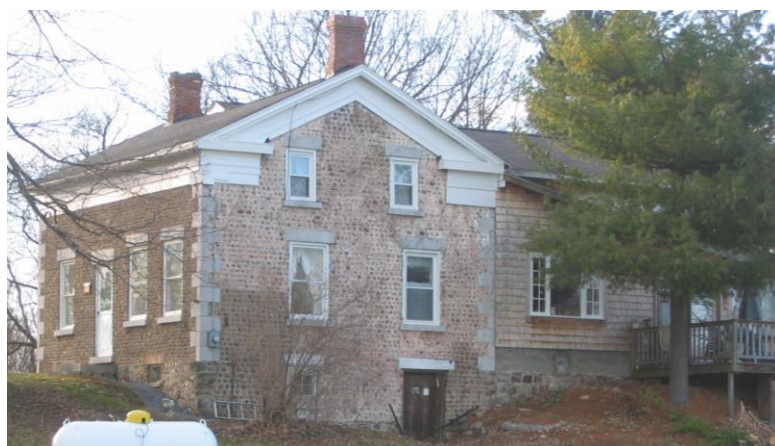
The Hicks House is found at 1515 O'Dell Road in the town of Junius. Note carefully the obvious difference in color of the cobblestones on the south (left) side compared to the east (right) side of the main part of this building. On the east wall there is a section of cobblestones that is darker (more like the color of the south side) than the rest of this side. This is because a former owner painted the cobbles on this east side which doesn't directly face the road.

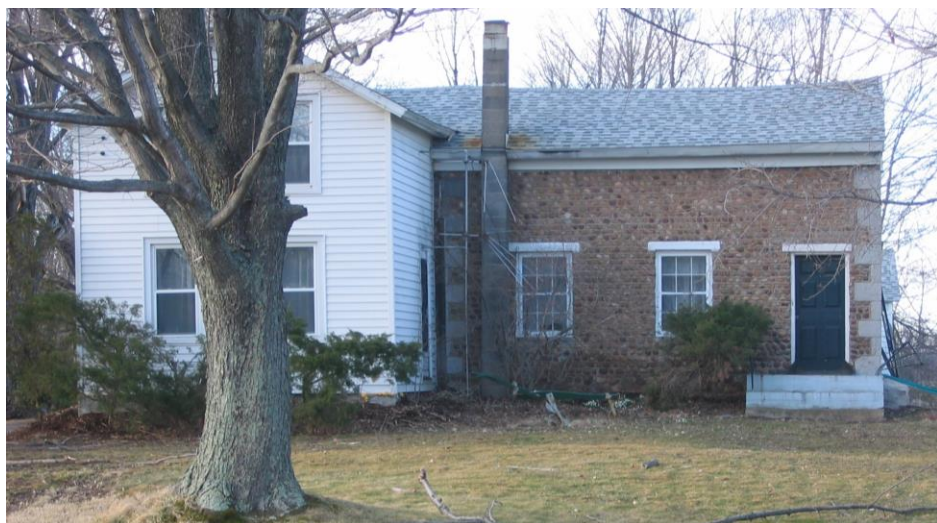
The Nearpass House at 543 Bedell Road in the town of Junius shows how the original cobblestone home is often added on to make a larger residence. In this case the additions are wooden. Note how the entrance door is placed to the right rather than centered on that side of the original cobblestone

structure. Also note the cut limestone blocks that make up the steps and landing to this entry door.

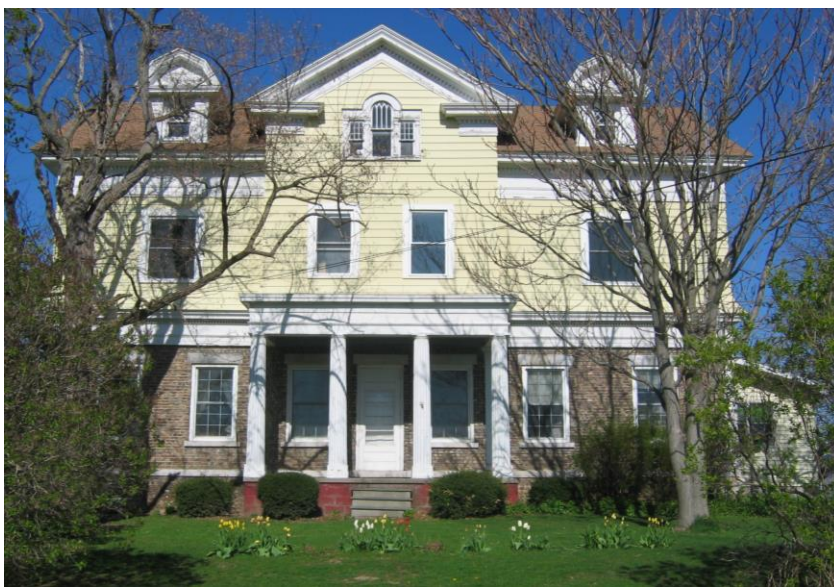
This house is at 3792 Post Road in the town of Fayette. Note how it appears that this was originally a one or one and a half story cobblestone house and then the roof was raised to make the two and half story house as it appears today. Notes how the wooden portion reflects many qualities of later building styles than that used in the cobblestone structure originally. The house today has a very pleasant appearance making uses of these different styles and building materials.
