Each Building Has Beauty Of Its Own

By William Aeberli

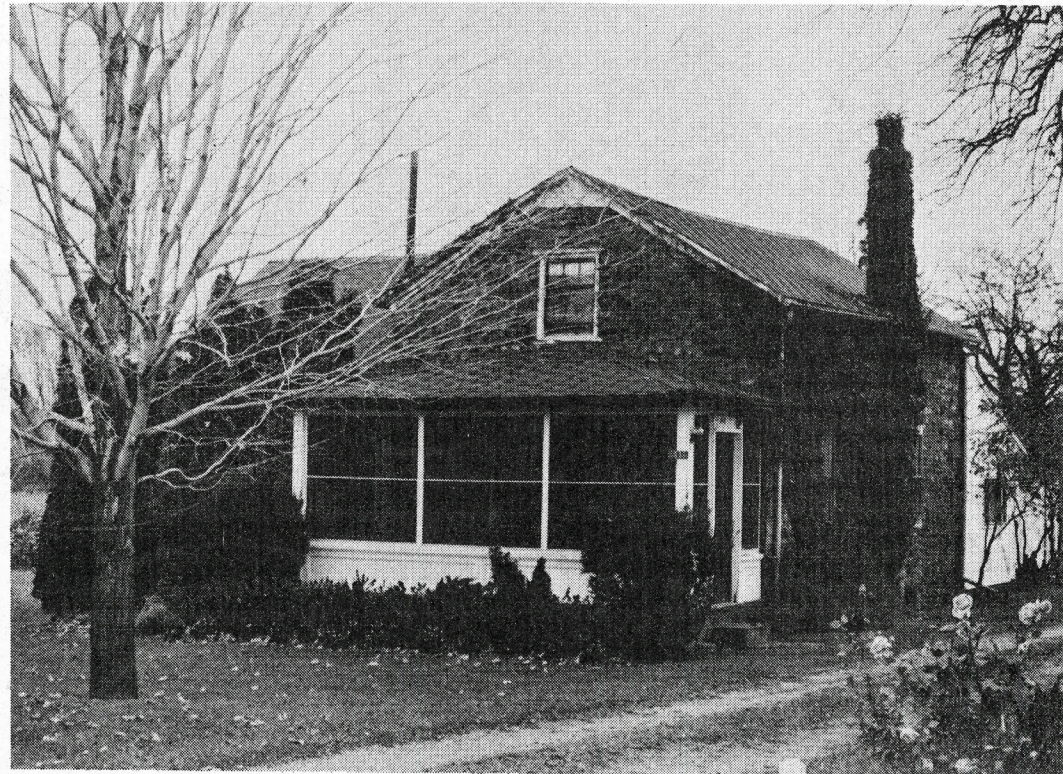
EARLY PERIOD--Lewandowski cobblestone on the Ridge was built almost entirely of fieldstone, around 1825.

The Lewandowski cobblestone cottage undoubtedly is one of the very early types of the 1825 era in this area, and is located at 15698 Ridge Rd. W., on the south side near the Hindsburg Rd.

The material is almost entirely fieldstone with 3 courses to a quoin. There was an attempt to protrude a few stones, here and there.

At first glance, the walls have a pronounced flush

appearance which gives off a dark, bluish-gray sheen effect when the sun is overhead. The climbing foliage across half the west wall completely covering the chimney blends with the mortar and material.
