## 55.- ISAAC NORRISON HOUSE

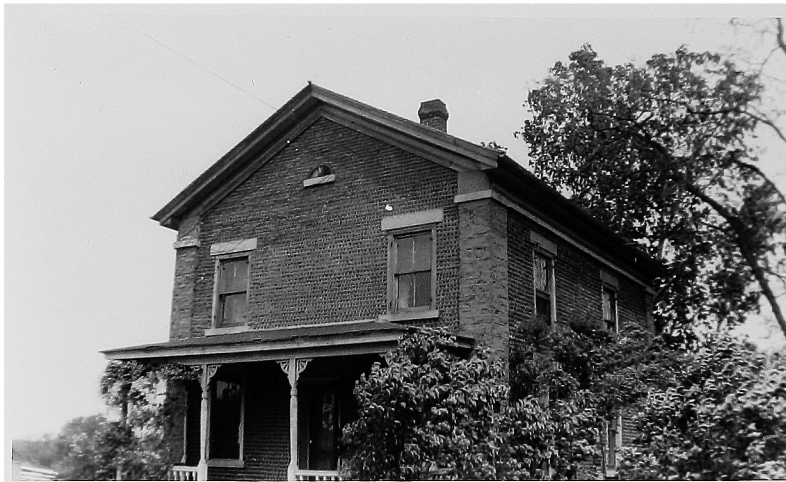
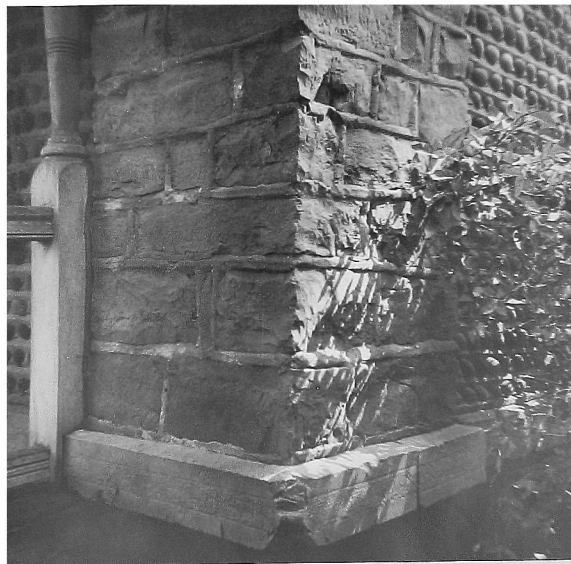
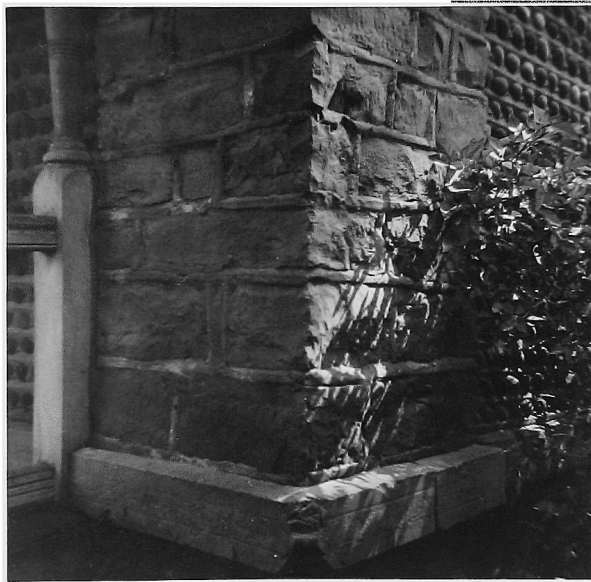
Quoins on house of Isaac Morrison  
on North Main Street in the Village  
of Marion.

STONES: Red lakestones constitute the facing for the front wall.

They measure  $1\frac{1}{2}$  -  $2\frac{1}{2}$  x 3 inches.

JOINTS: Pyramids were used as vertical joints and a 1 inch V as the horizontal. A course is 3 inches.

QUOINS: Rough cut limestone makes up the unusual quoins.

LINTELS: Lintels are tooled limestone.

SIDE : Larger, all colored lakestones are found at the sides.
