27- 72 MAPLE AVENUE, SODUS

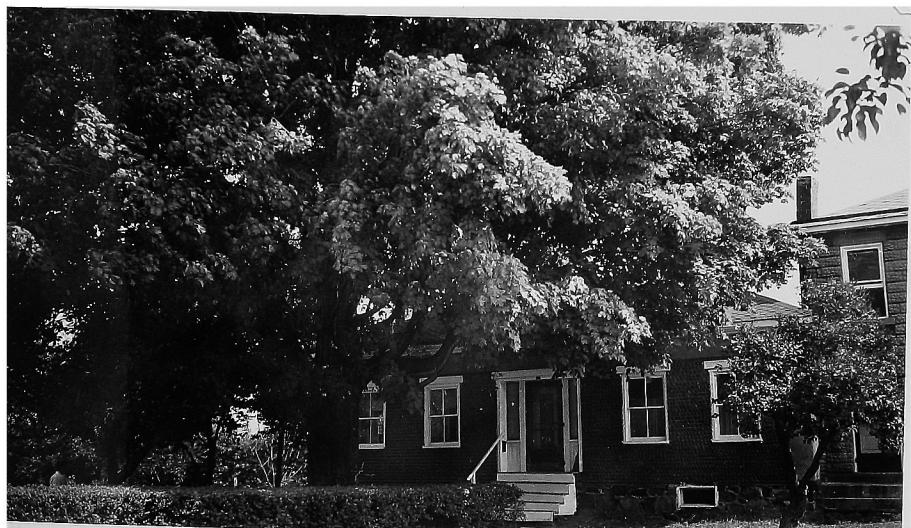
This house on 72 Maple Avenue is unusual in two respects. First, it has concrete pilasters. Second, and I believe more important, there are no definite vertical joints. Instead the horizontal has no boundaries and extends continuously through the course thus:

STONES: The red lake stones are $2-3\frac{1}{2}$ x 2 inches. Courses are 3 inches high.

JOINTS: The horizontal V (in this case the space between the stones) is $\frac{1}{2}$ to 1 inch wide.

LINTELS: The lintels are wooden.
