/6.-PATTESICT HOUSE ON THE EAST WILLIAMSON RD.

Mr. Pattesict owns this house on the East Williamson Road north of East Williamson. The builders--the Hance brothers went broke during the construction. They had to sell it after which the second part was added.

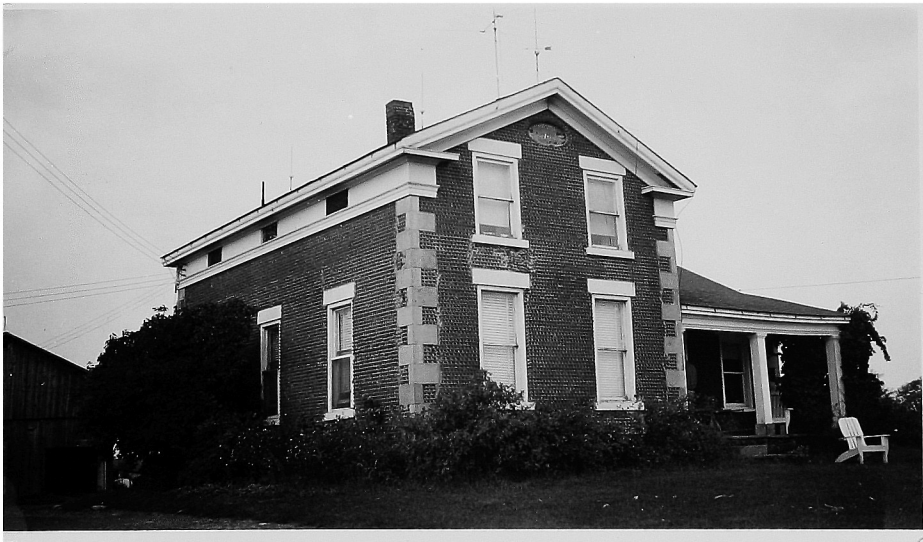
JOINTS: The horizontal joint is rather unusual. It is neither a true V or bead. It is neither pointed at the end. The shape has not been clouded by weathering. It is shaped thus;

The vertical joints are V's and pyramids.
