# Historic Childs: 2 Cobblestone homes near Museum on the Ridge stand test of time

**By Doug Farley, Cobblestone Society and Museum Director**

GAINES – The Historic Hamlet of Childs is home to the National Historic Landmark Cobblestone District with three cobblestone structures that comprise a portion of the buildings owned by the Cobblestone Society & Museum.

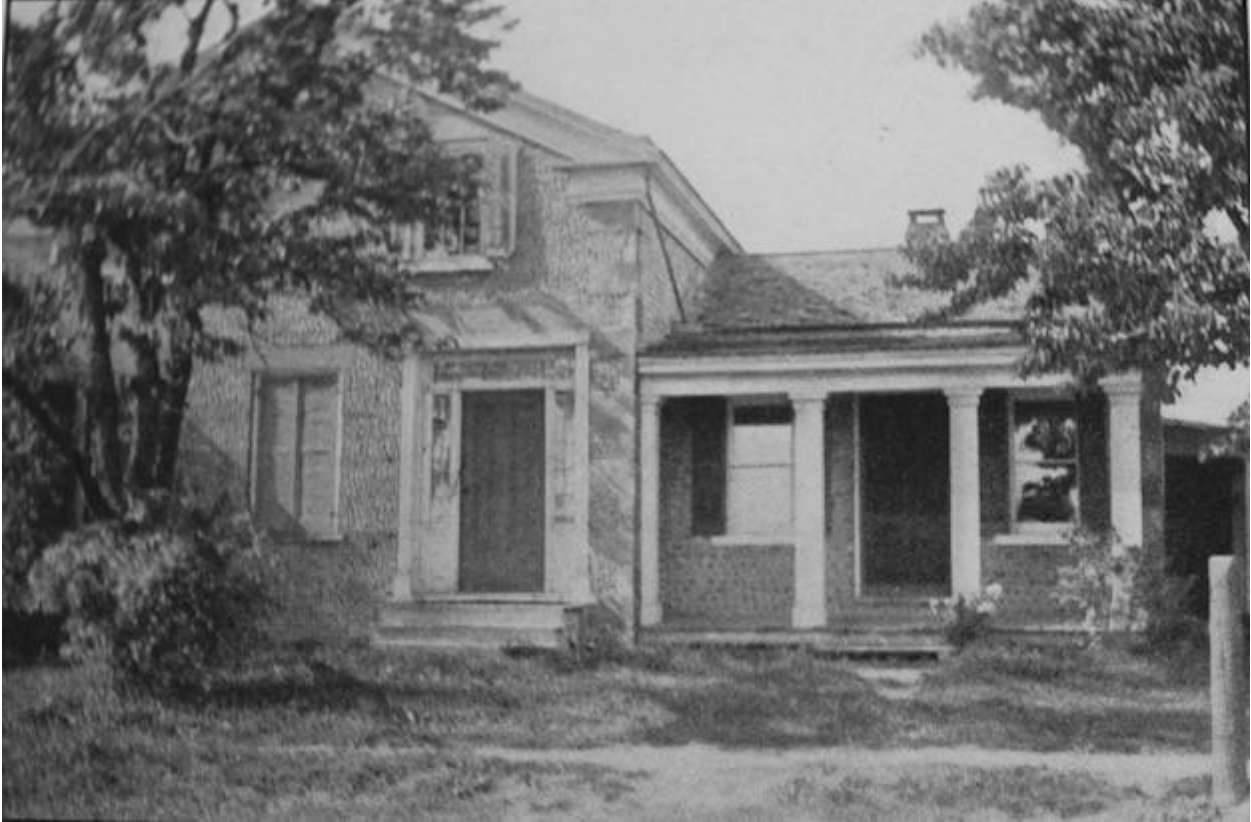
This image depicts what the larger of the two homes looked like in the late 1800s. It was originally a two-story Greek Revival farmhouse with a one-story wing. William Cook, the minister at the Universalist Church, bought this home in 1850. He chose not to live in the church's two bedroom cobblestone parsonage, because he had 12 family members under his care. Note the entablature, the wooden trim just under the eave of the second story.

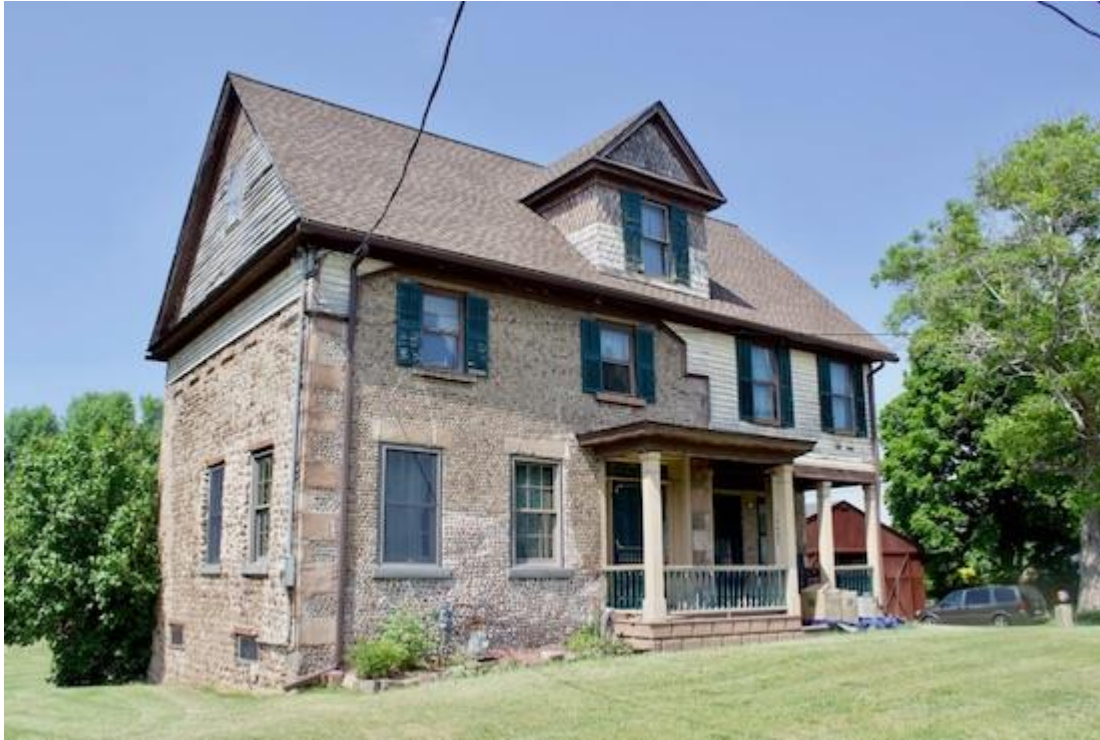
The Robinson's home has undergone a number of additions that have given the home a truly unique appearance today. It was substantially altered in appearance at the turn of the 20th century when a wooden second floor was added to the east portion, along with a full attic with a central bay window. Most distinctive of these alterations is that the gable was rotated 90 degrees.

The Greek Revival entablature was removed and replaced with clapboard. This gives us a peak at construction details normally hidden. Near the top of the cobblestones of the west wall, we can see the wooden blocks that were originally inserted in the stonework to allow the bottom of the entablature to be nailed. It also indicates that cobblestones were not laid behind the original entablature.

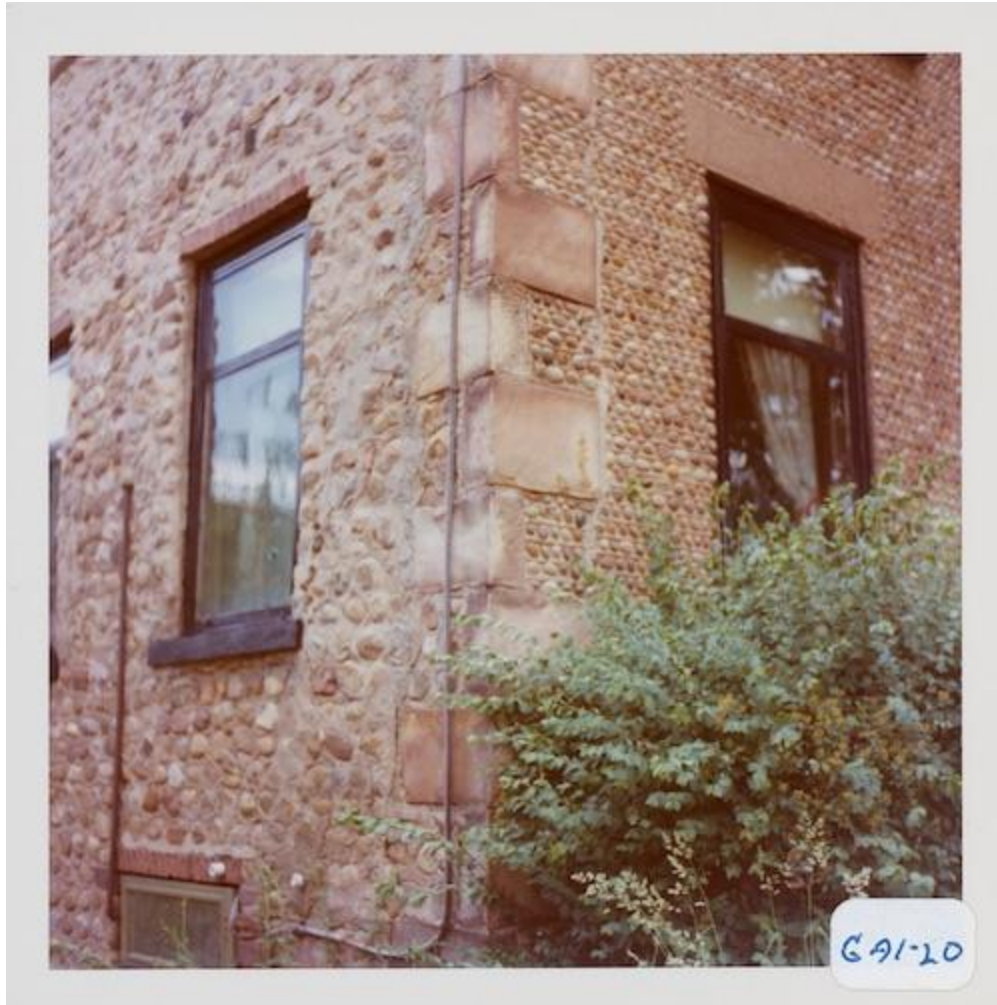
Here we can clearly see the large sandstone quoins that form the corners of the structure. Cut stone quoins were used to give cobblestone buildings watertight corners. Also shown here is the difference in the size and pattern of stones used at the front and sides of the building. The highly visible front has six rows of small water-washed cobblestones per sandstone quoin and the sides were constructed more hastily with large glaciated fieldstones, three rows to the quoin.

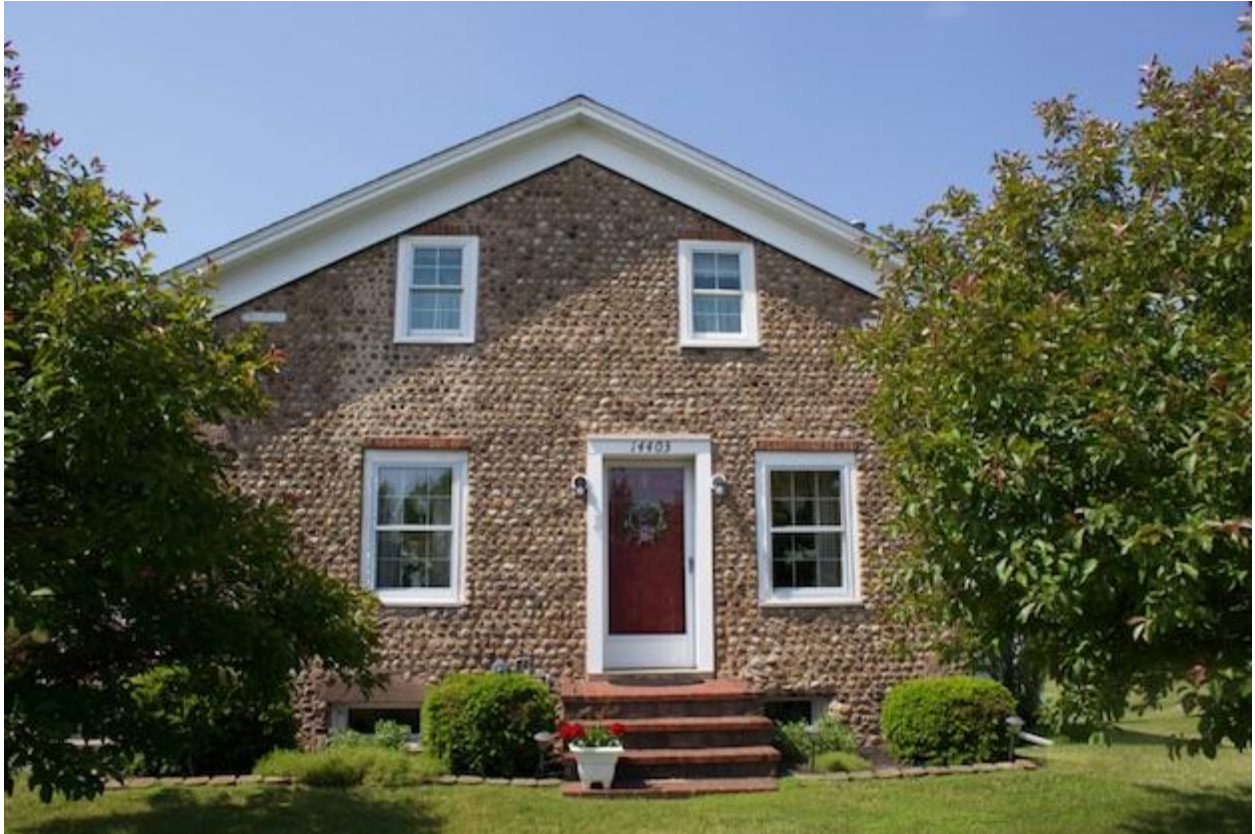
The smaller of the two “extra” cobblestone structures in the Cobblestone District was built by John Simmons on land purchased from community founding father, John Proctor. We know of another cobblestone building constructed by Simmons: Carlton’s Baldwin Corners District #6 schoolhouse.
