Bethinking of Old Orleans

TOWER RESTRUCTION

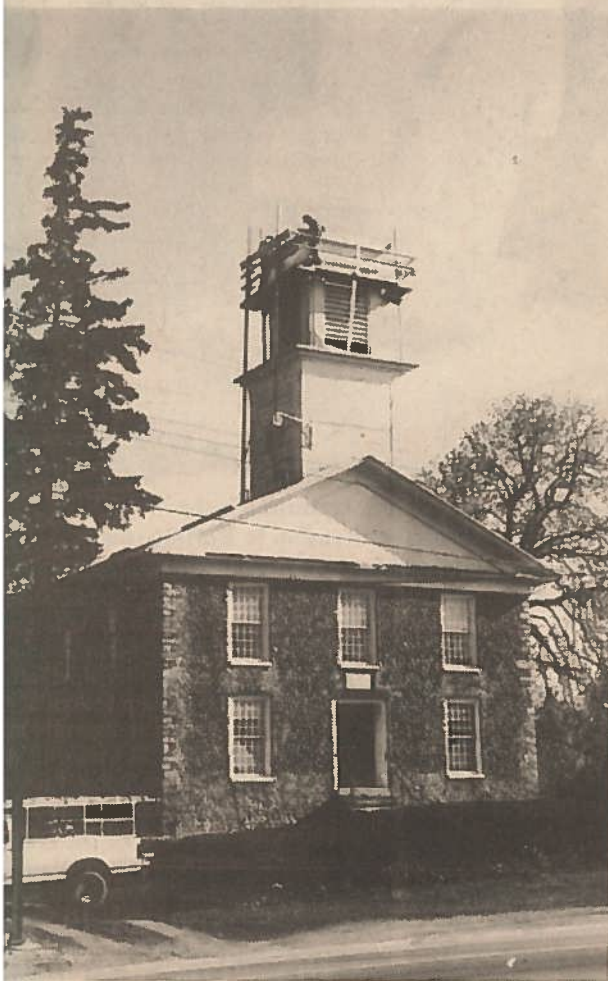
The accompanying photo shows the Cobblestone Church in Childs as it presently appears with scaffolding. The tower, which has been a cause of concern for a number of years, because of leaking, is now being reroofed. This historic cobblestone landmark was erected by the First Universalist Society in 1834. In 1919 the original tower was dismantled because it leaked and was deemed unsafe. In 1964 it was decided to restore the bell tower to this landmark which was paid for with funds (\$6,000) given by John D. Brush in memory of his mother Eva M. Brush. A bronze tablet in the cobblestone church lobby indicates this also noting: "A Mother, Earth's Most Godlike Creation". Using old photographs as reference for the restoration, O.W. Shelgren, Jr. of Buffalo designed the

Once the scaffold was put up Joe and Tom could examine more closely the tower and its problems. Fortunately, it rained while they were doing this which led them to discover the place of intrusion. Water, during certain wind conditions, was filtering in at the very top around a moulding and then running down behind pilasters, where it dripped. Hence, the very upper portion of the tower has been modified to correct the situation, although it will appear the same. Likewise, galvanized roofing has been installed on top and on the ledge which will make it impervious for years to come. As part of this restoration, the tower will also be primed and painted. Following this, restoration of plaster work and interior painting will occur, greatly upgrading the appearance of one of Orleans County's most noteworthy historical landmarks.

It goes without saying that sometimes towers, chimneys, cupolas, skylights and flat roofs leak incessantly and trying to find the leak is next to impossible. The Cobblestone Board of Directors was determined to solve the mystery and correct the problem. Don Ross as financial officer, was put in charge of seeking funds and finding a contractor to do the job. Estimates ranged from \$5,000 to \$28,000. Through Don's efforts, the Cobblestone Museum received a grant of \$5,000 via the Gene-see Park Commission, which was made possible through the offices of Senator Daly and Assemblyman Hawley. The museum also received the remaining amount to restore the tower from the Orleans County Foundation. This amounted to \$8,350 making up the total estimate of \$12,350 from Joe Baker's Quality Construction. In fact, that's Joe and his associate Tom Fien in the photo of the tower shown here.
