# Bethinking of Old Orleans

## A JOB WELL DONE

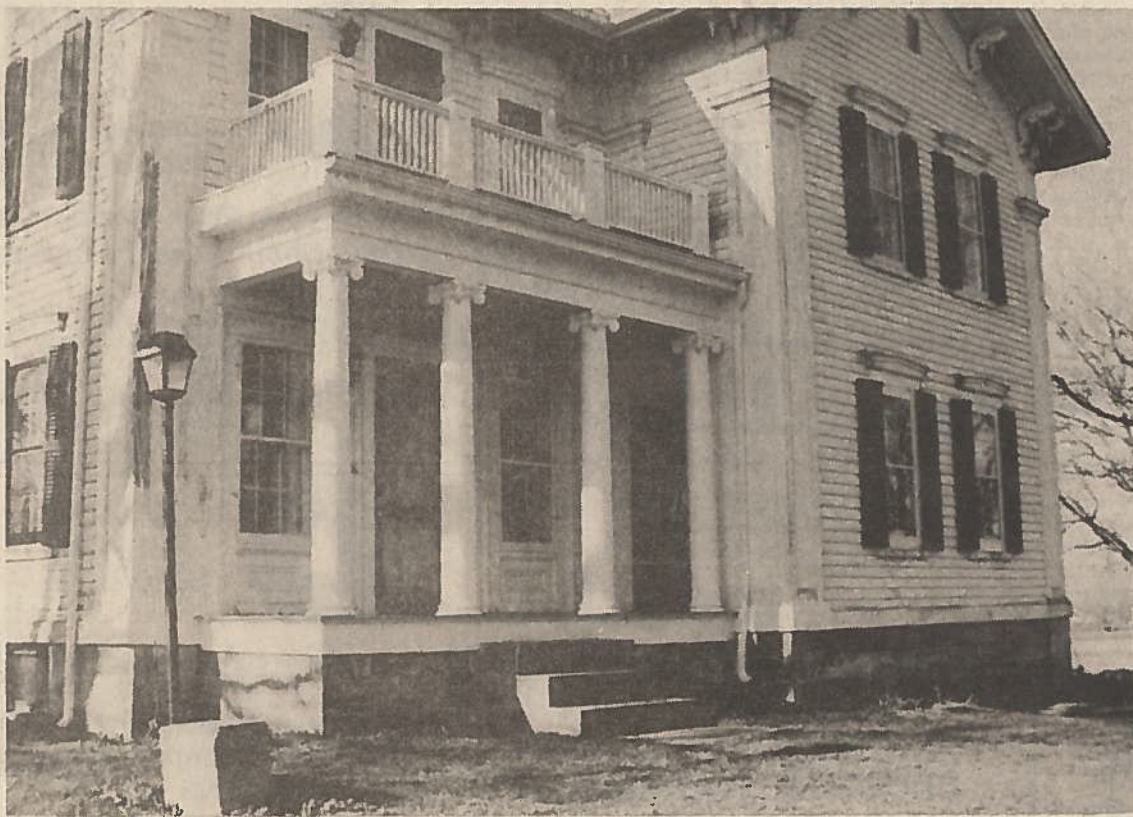
As to the porch, Bonnie did her homework so as to have it look right when restored. The former porch was removed because of serious water damage and it was not the original one on the house. Bonnie had already designed what you see in the photo before the former porch was removed. A "ghost" of the original was behind it all revealing an outline which Bonnie's drawings matched. You see, she knows what she's doing!

The house which was probably built in the 1850's is what we might call a transition piece. It has both original Greek Revival details and Italianate details. The pilasters are certainly Greek in origin while the overhang has the typical Italianate brackets. The former porch had been extended beyond the pilasters thus covering them. Bonnie, in her plans, recessed the porch to its original location.

The columns used here in the Greek styling, came off Laurita Payjack's home. This is especially meaningful to Lisa as Mrs. Payjack was her grandmother. Indeed, there is something to be said for recycling architectural house parts.

The actual construction work on the porch was done by two local firms. Bradley Rath did the cut stone restoration and the Zacher Bros. Construction Co. did the carpentry. In summation, Tim and Lisa have ended up with a beautiful restored front porch which will add beauty to their home for a life time. Bradley Rath and the Zacher Brothers can be very proud of their skills. This is certainly a testimony of quality work for future restoration projects. And finally, never but never, underestimate the professional consultation services of an architectural designer.
