# Widening the Erie Canal

## Bethinking of Olde Orleans

The accompanying picture of the widening of the canal was taken in 1912 looking east toward the Beals Road Bridge in the Town of Ridgeway. This was during the time of expansion of the old Erie Canal to what became known as the Barge Canal.

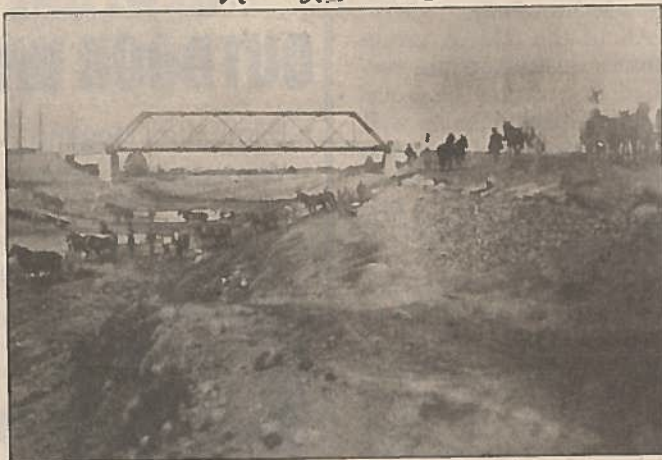
Most of the teams appear to be pulling a dump scoop with two handles, which the man took hold of pushing the scoop into the earth as the team went forward. When the scoop was filled, the horse dragged it to where it was dumped. Hence, we notice a wooden ramp from the canal basin up to the north bank.

When this widening project took place, the canal bottom was not only deepened, but the banks were raised to gain the now proper depth of 12 feet. In many places, the south

bank did not have to be built up as seen here. It was only the north bank and towpath that were raised.

In the immediate foreground of this picture, earth is yet to be removed and rip rap placed along the south bank. Rip rap in this case is irregular pieces of

Medina sandstone. Usually scrap stone are thrown together to make a sloping embankment.

The bridge in this picture is indeed the current Beals Road Bridge right after its installation. Power and telegraph poles may also be seen all along the north side of this canal.

What strikes me immediately about this picture are the number of horses. In fact, there are 15 teams — 30 horses — shown here.

There is, however, not one single piece of mechanical equipment to be seen. There are no steam engines, no steam shovels and no steam derricks. Therefore, this picture translates as a work force of horse power and man power.
